Seismic Performance of Passenger Elevators in Taiwan

George C. Yao ¹⁾

*1) Department of Architecture, National Cheng Kung University, Tainan, Taiwan
701, R.O.C.*

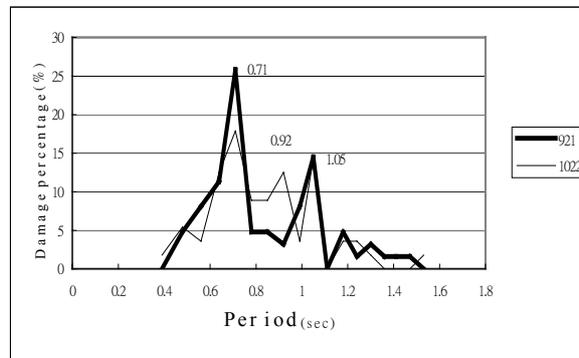
Fig. 2 Building fundamental period distribution with damaged elevators

Fundamental period distributions for these buildings are shown in Fig. 2. It is observed that there are three major peaks in the damaged building periods. The damage percentages from high to low were 0.71, 1.05, and 0.92 second. Each of these periods corresponds to a 7-, 12-, and 10-story building. Comparing to Fig. 3, these buildings' fundamental frequencies all fall within the peak frequency ranges of both earthquakes. Confirmation from the elevator companies agreed that these three building heights constituted most of the damaged elevators.

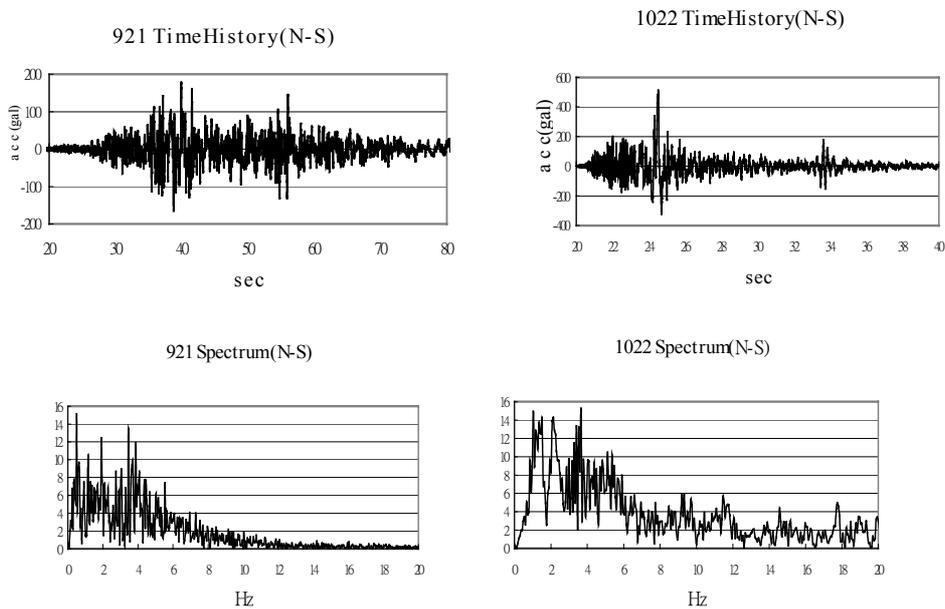
Fig. 3 Time history and Fourier spectrum of station CH047 in two earthquakes

to the large high frequency contents in the 1022 earthquake comparing to the 921 quake, as shown in Fig. 3. The frequency components above 10Hz is richer in the 1022 data. The flexible CW system has a low natural frequency [4] and was not greatly magnified by the high PGA values rooted in the high frequency contents in the 1022 earthquake.

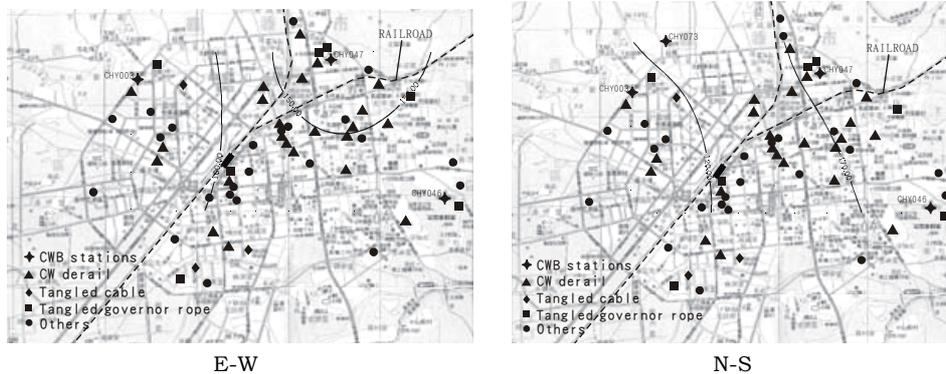
Fig. 5 PGA contour map and the damaged elevators in the 921 earthquake

PGA contour maps from the recorded 921 and 1022 earthquake in Chia-Yi city were generated from Table 2. The location of buildings, which suffered various types of elevator damage, was identified on the same map for comparison, as shown in Fig. 5 and Fig. 6 for both earthquakes. Because 921 quake had a smaller PGA in all stations than the 1022 quake, the smallest PGA to produce different types of elevator damage can be identified by analyzing the 921 contour map in Fig. 5. In the 921 quake, the EW PGA was smaller than the NS PGA in every station was. Therefore by interpolating the NS PGA in Fig. 5., the smallest PGA to generate CW derailment was estimated to near 75 gal. The same analysis approach indicated that the smallest PGA started to generate governor rope damage was approximately 115 gal.

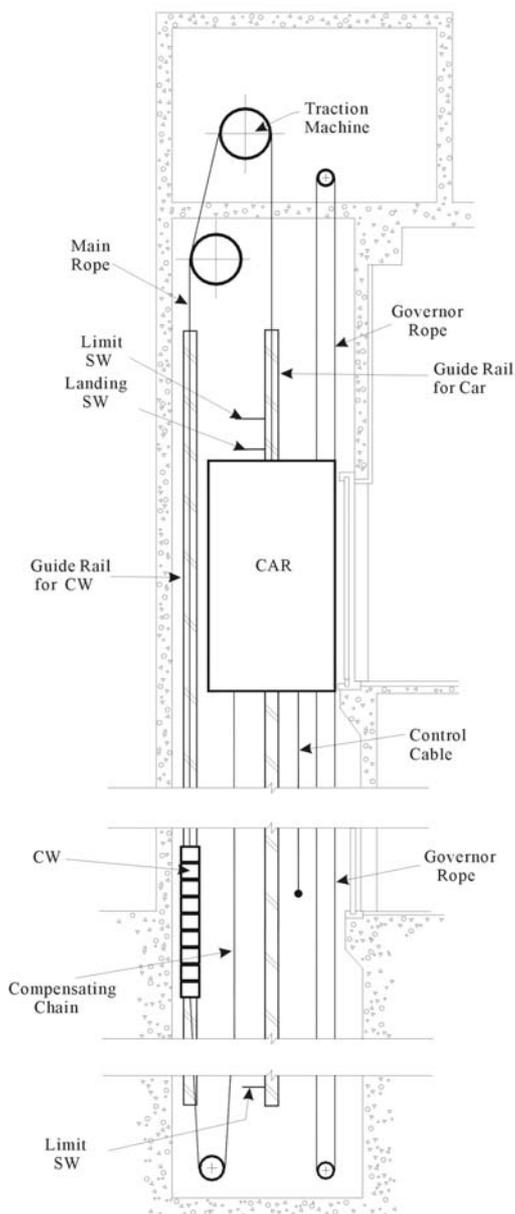
Fig. 7 Vulnerable elevator components

According to Table 1 and the discussion in the last section, it was noticed that several major components necessary for maintaining elevator functions were vulnerable to earthquake attacks. The reasons for this vulnerability and the damage mechanisms are discussed below based on investigations and discussions with elevator engineers from various maintenance companies. Figure 7 depicts most of the critical items in an elevator hoistway.

derailed CW cage hit the car and deformed part of the cab. Fortunately no one was injured because it happened at night. Most of the CW cage derailments took place on the 5kg/m guide rail. There were two mechanisms for this derailment:

1. The in-plane vibration of the CW cage resulted in pounding with guide rails and deformed the rail. As a result, the cage was released from its tracks to swing freely in the hoistway. Damage of this mechanism made up roughly 60% of the CW derailments. When this happened, the deformed rail and sometimes the rail brackets would need replacement before the elevator could return to service. The installation of new rails and rail realignment might take several days to complete.

2. The out-of-plane inertia force pushed the CW cages against the rail surface and forced the guide shoe to rotate along its connection end. Because only two bolts were used to tighten a shoe, one on each side, the shoe acted like a semi-rigid connection.

When the pushing created large shoe rotation, derailment could take place. Damage of this mechanism made up approximately 40% of the CW derailments. If the rails were not bent into permanent deformation, the repair work could be finished in about one hour. Otherwise rail replacement would be necessary and it took several days to finish. Major problems with CW derailment involved the rail cross section. The most commonly used CW guide rail for low-rise residential buildings has been the 5kg/m rail type, see Fig. 4, which is made of a steel plate formed rail. This rail type constituted 95% of the derailment cases. Usually when the load requirement for a higher capacity railed is needed, the next level up is the 8kg/m rail, which is made from hot-rolled T section steel. The 5kg/m rail is much weaker than the solid hot-rolled section in terms of stiffness and strength. Also, the alignment at the 5kg/m rail junctions is usually poor, therefore a larger tolerance at the guide shoes is required. The enlarged distance also increases the possibility of derailment in earthquakes.
