Seismic Performance of Highway Bridges

ABSTRACT

The 921 Taiwan Chi-Chi earthquake incurred tremendous disaster to the central region of the island, particularly to Taichung and Nantou counties. Most of the bridges on the provincial and county routes in Taichung, Nantou, Changhua, and Yunlin counties escaped from serious damage, while approximately 20% of them suffered minor-to-major damage. The construction completion dates of those bridges range from 1960 through 1999. Damage to these bridges include fault rupturing, collapsed spans, landslides, soil settlement, slope failures, flexural and/or shear failures, and liquefaction. This paper begins with a brief description on the evolution of seismic design code for bridges in Taiwan, followed by a general depiction of the performance of highway bridges located in the four counties during the earthquake. Several major damaged bridges with typical damage modes are illustrated and explored. Lessons learned from the field observations and suggestions made on research needs are also discussed.

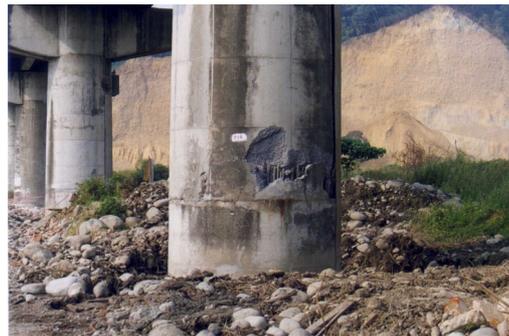
Fig. 2(a) Damage to the column of the Ta-chia-shi bridge

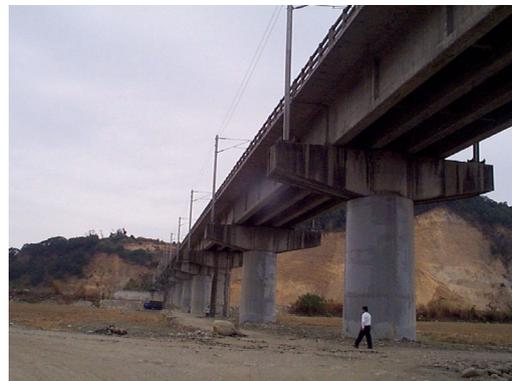
Fig. 2(b) The repaired column of the Ta-chia-shi bridge

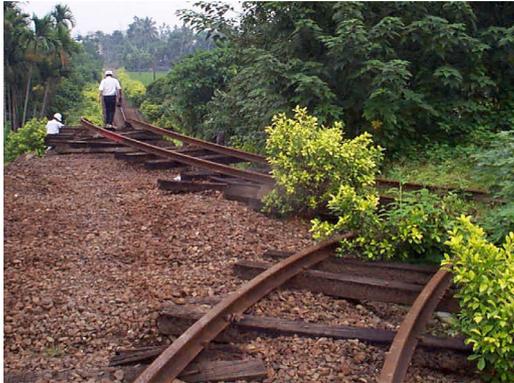
(PGA) measured from ground motion fault rupture and land dislocation. The distorted rail and a vertical drop of about 3.0 meters are shown in Fig. 2(c) and Fig. 2(d). This branch of the railway still remains closed today.

Fig. 2(c) Distorted railway of the Chi-Chi Branch

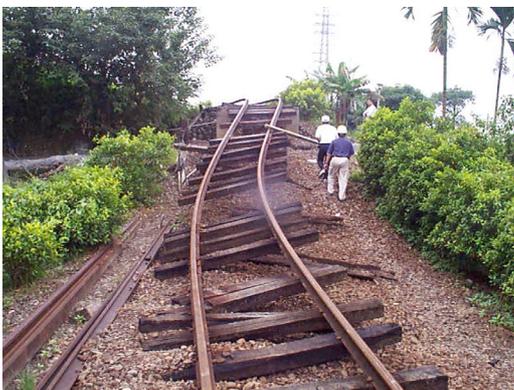
Fig. 2(d) A vertical drop at the Chi-Chi Branch

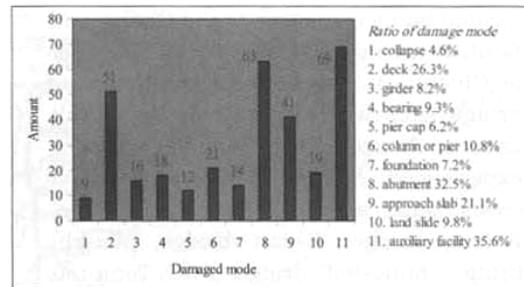
Figure 3(a) shows a summary of comparison among 11 different damage modes. It should be noted that an injured bridge often has more than one damaged mode, so the total amount of all terms exceeds 195, which is the number of all injured bridges in the inventory. It

Fig. 3(a) A summary of different damaged modes

is seen that in these 195 bridges, the ratios of damage to auxiliary facility, abutment, deck, and approach slab are 35.6%, 32.5%, 26.3%, and 21.1%, respectively, significantly larger than those of other damage modes. From the field observation, it was found that pounding on abutments due to excessive longitudinal vibration of the superstructure usually occurred with damage to the approach slabs and/or bridge decks. The deck damage defined in this paper includes the expansion-joint failure. In addition, the

ratio of column or pier damage (10.8%) is greater than those of bearing (9.3%), girder (8.2%), and foundation (7.2%). From the reconnaissance results [5], it was observed that half of those bridges with injured bearings were also with damage to the corresponding columns or piers. Some damaged bearings were due to crack of their pedestals, and some were due to dislodgment by the supported girder.

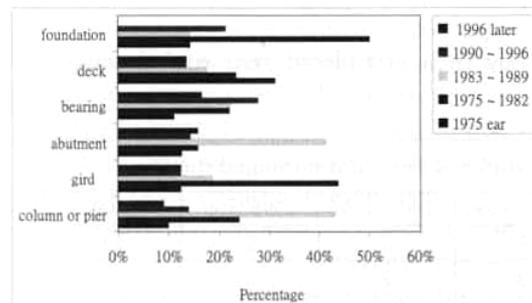
Table 4 is the result of an aggregation of some damaged modes by the completed year of bridges. It is observed that the amount of damaged abutment and deck are usually in the first two ranks for any construction period. Figure 3(b) exhibits the relative percentage of damaged modes for a specific construction period. It is seen that for any construction period considered, the abutment and deck are more liable to damage than other components under the earthquake. The susceptibility of column or pier damage decreases in the latest three construction periods, while it is not the case for the bearing systems. A decreasing trend of

Fig. 3(b) Relative percentage of damaged modes for a specific construction period

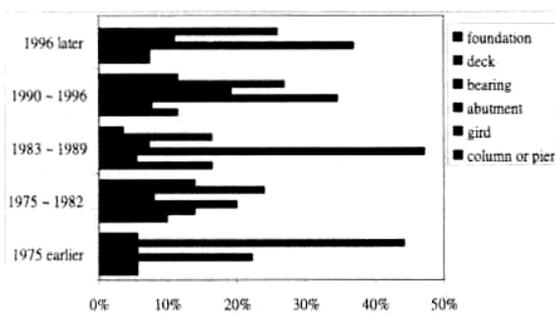
Figure 3(c) shows the variation of the six damaged modes with the construction periods. It is observed that most of the six damaged modes occur in terms of higher damage percentage in a certain construction period than in others, except for the bearing-damaged mode. Generally speaking, over 70% of the damaged bridges for each mode other than the bearing-damaged mode were completed before 1989. Those bridges with damaged bearing systems disperse in each construction period with a nearly uniform way.

Fig. 3(c) Variation of the six damaged modes with the constructed periods

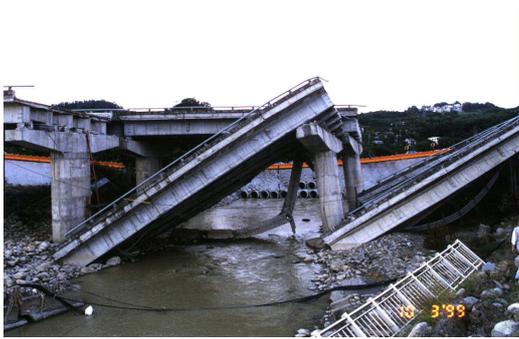
Closing to the southern abutments, two consecutive spans of the southbound bridge and one of the other collapsed, as shown in Fig. 4(a). The retaining wall near the southern abutment collapsed, as shown in Fig. 4(b). The first pier including caisson in both bridges tilted away from the southern abutment northeastward, and the abutment tilted northwards (Fig. 5). Figure 6(a) shows that some shear cracks occurred on the first column bent extending from the northern abutment of the northbound bridge. Moreover, almost all the concrete stoppers on the pier cap of the second pier were crushed (Fig. 6(b)) and transverse movement of the middle span, which escaped from collapse, was observed.

Since there is no significant flexural or shear crack observed on the tilted column bents, it seems that fault rupture near the southern abutment may be responsible to those tilted piers. It thus appears that those two collapsed spans close to the abutment were induced by the tilting column bents. In addition, the measured horizontal PGA is as high as 500 gal in the transverse direction and 350 gal in the other. Supported by one tilted column bent, collapse of the middle span of the southbound bridge may be due to excessive in-plane displacement under the strong ground motion. However, the middle span of the northbound bridge may have been experienced less displacement and thus escaped from collapse.

Fig. 4(a) Three spans collapsed (Shi-wei bridge)

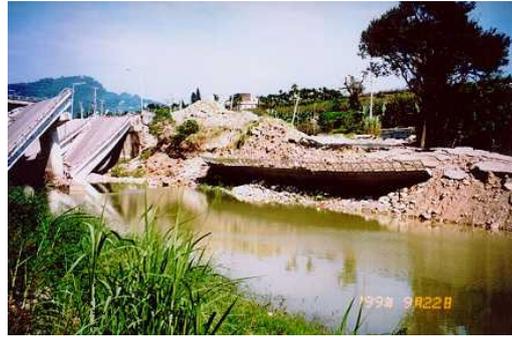
Fig. 4(b) The southern retaining wall collapsed (Shi-wei bridge)

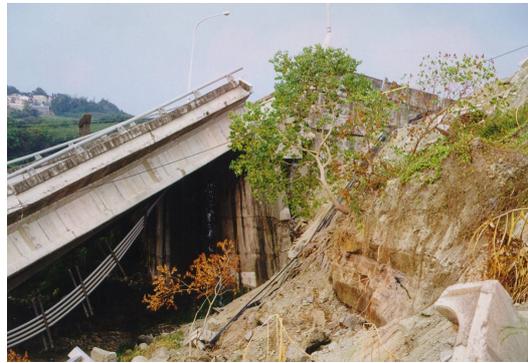
Fig. 5 The southern abutment tilted northwards

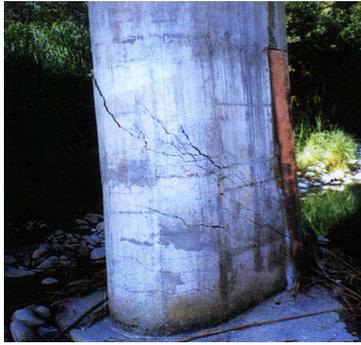
Fig. 6(a) Shear cracks at the first column bent of the northbound bridge

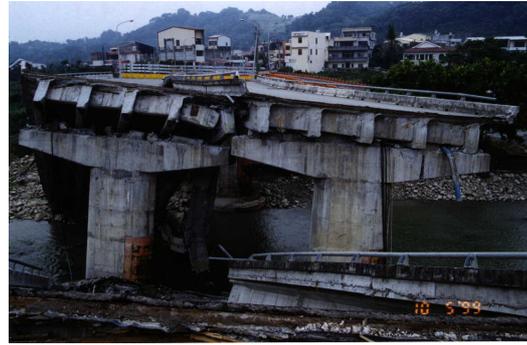
Fig. 6(b) Crushed concrete stoppers on the pier caps

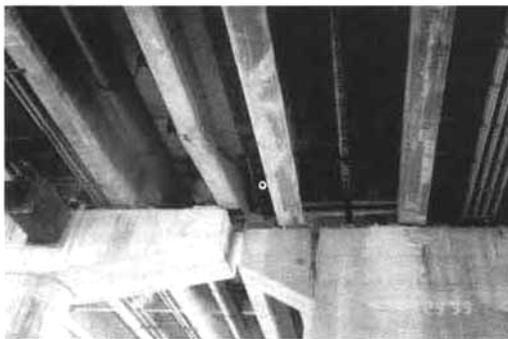
wall-type piers and single column bents, respectively, on spread footings. Under the strike of the Chi-Chi earthquake, strong transverse shaking moved the superstructures southward and some bearings were dislodged (Fig. 7). Even more, as shown in Fig. 7, the prestressed concrete girder was fractured near the beam end. Figure 8 shows settlement of the bridge deck due to loss of support by bearings. Significant flexural/shear cracking and spalling occurred in both the sixth column bents extending from the eastern abutments of those widened bridges (Fig. 9(a) and 9(b)).

Fig. 7 Southward movement of the superstructure and the fractured girder

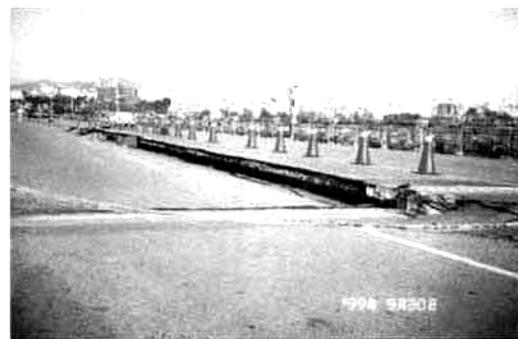
Fig. 8 Settlement of the bridge deck (Dong-feng bridge)

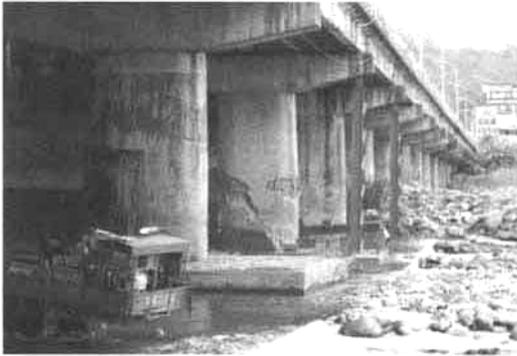
Fig. 9(a) Flexural/shear cracks at the 6th column bent of the westbound bridge

The Chelungpu fault did not pass through the Tong-feng bridge, but evoked strong ground motion in the vicinity of the bridge with a horizontal PGA of 500 gal in the longitudinal direction and of 350 gal in the other. Such large shaking made the bridge girders move southwards and even fall down from their bearing supports. As a consequence, sinking of the bridge deck resulted from the southward movement of girders. Furthermore, since the column bents of the widened bridges are not as wide as the wall-type piers of the original one, they reserve less shear and flexural capacities than the old one does. It is thus plausible that the column bents experienced much more severe damage than the wall pier.

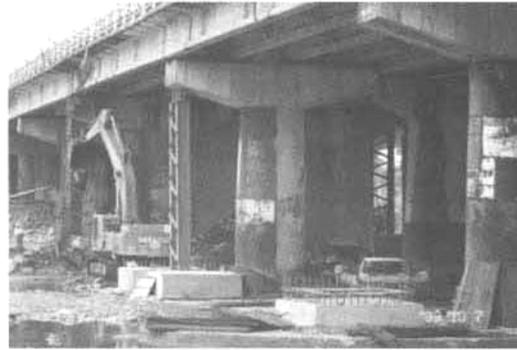
Fig. 9(b) Flexural/shear cracks at the 6th column bent of the eastbound bridge

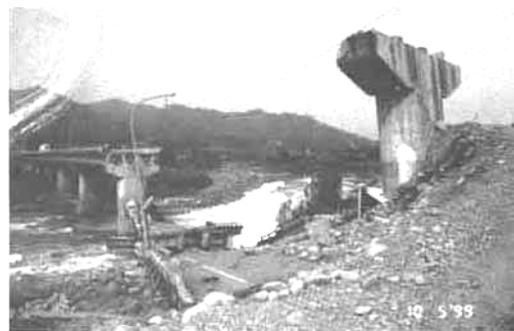
abutment collapsed, and the second column bent along with its caisson was uprooted and lay down on the riverbed, as shown in Fig. 10 and Fig. 11. The collapsed second and third spans rotated clockwise as they fell down on the riverbed. Except those collapsed spans, there is no evident damage to the rest components of the bridge.

Since there is no significant flexural or shear crack observed in the lain down pier, it is believable that ground rupture through the pier toe led to its failure. A permanent drop of the riverbed, as shown in Fig. 12, verifies the pass of the Chelungpu fault through the bridge.

Fig. 10 Three spans of the Pi-feng

bridge collapsed

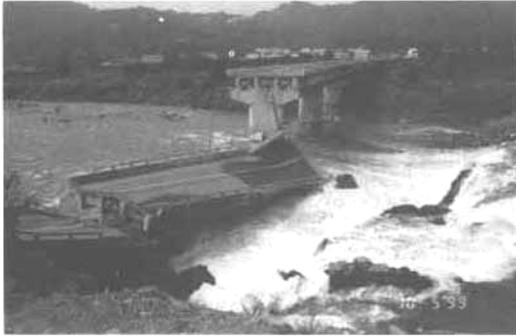
Fig. 11 The third collapsed span of the Pi-feng bridge

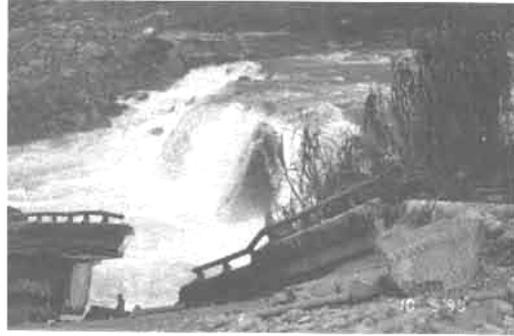
Fig. 12 A permanent drop of the riverbed induced by fault rupturing

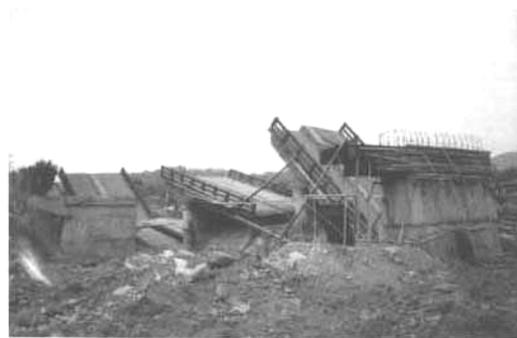
A field examination indicated little damage to those collapsed girders and to the southern half of the bridge. It appears that those collapses were caused by large ground movements of their foundations towards the southern abutment rather than caused by excessive structural vibration.

Fig. 13 The “seesaw-like” collapse of the E-jian bridge

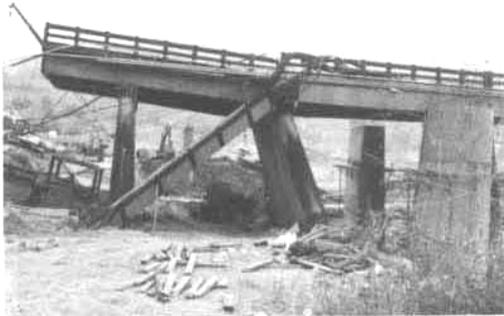
the other abutment as rigid bodies or rotated with their spread footings due to ground movement (Fig. 14). Relative movements between adjacent spans were observed for some of those spans remaining supported by their piers, as shown in Fig. 15.

Fig. 14 Movement or rotation of the pier walls (E-jian bridge)

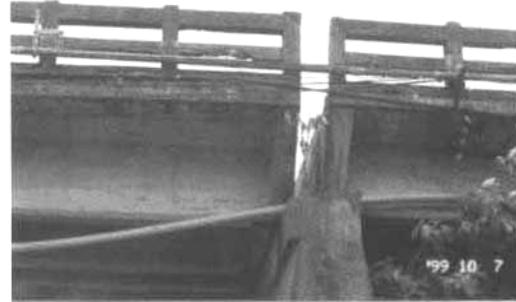
Fig. 15 Relative movement of adjacent spans (E-jian bridge)

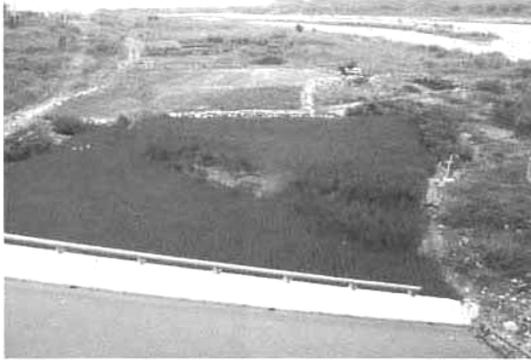
Fig. 16 Evidence of fault crossing the Wu-shi bridge

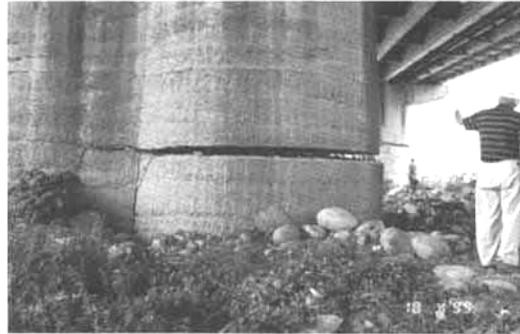
the northbound bridge did not experience such massive shear failure, but flexural cracks with fractured reinforcements were observed in the third pier wall from the northern abutment (Fig. 18). Moreover, the first two spans from the northern abutment of the northbound bridge were unseated (Fig. 19) due to the ground movement. The bearings at these pier caps were heavily damaged due to strong transverse shaking, as shown in Fig. 20. The third span especially exhibited a westward permanent offset. In addition, the super-structure of the southbound bridge showed westward settlement (Fig. 21) due to sliding down of those injured piers and caissons along their diagonal shear cracks.

Fig. 18 Flexural crack at the third pier wall of the northbound bridge

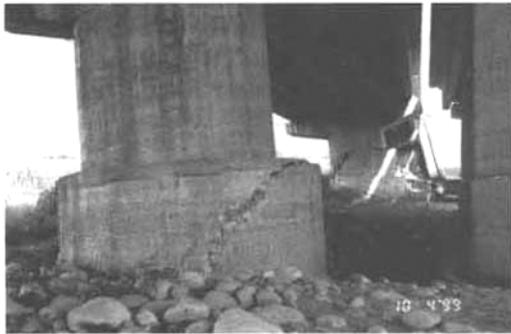
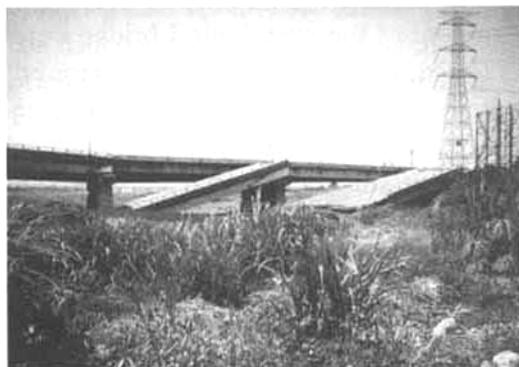
Fig. 19 The first two spans of the northbound bridge collapsed

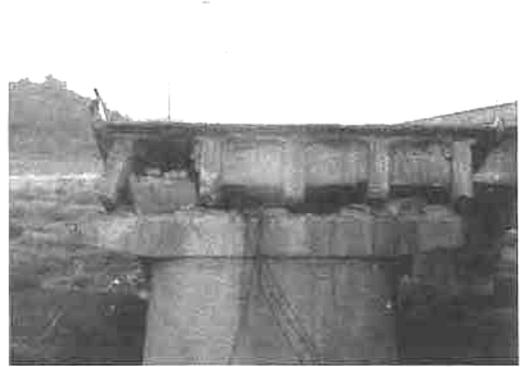
Fig. 20 Crushed bearings and diaphragms at the pier cap

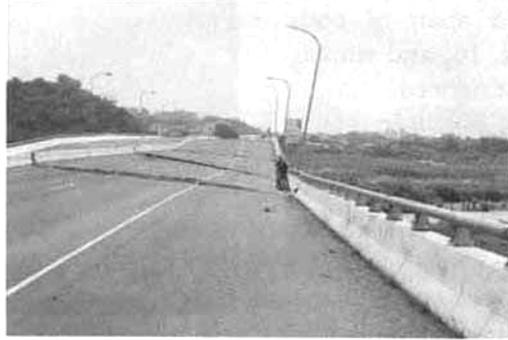
Fig. 21 Westward settlement of the superstructure

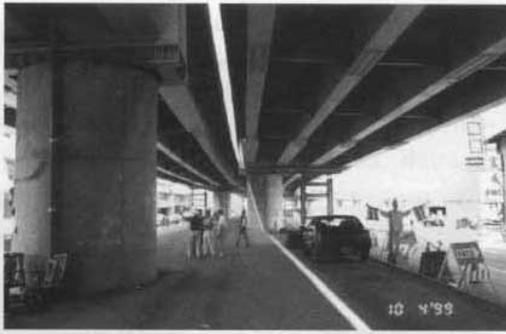
In an 8-span, curved segment, 4 single column bents are eccentrically connected to their steel cap girders, as shown in Fig. 22, in order to keep traffic flow fluent for the highway below it. During the earthquake, diagonal shear cracks occurred at the upper portion of those columns with eccentric connections (Fig. 23). Even more, the confinement hoops are exposed for some cases (Fig. 24). The steel cap girders were temporarily shored to prevent sinking of the superstructures. Since there is no damage to those single column bents with symmetrical connections, it appears that the eccentric connection may be one of the reasons for the damage.

Fig. 22 The eccentric connections of the Mao-loh-shi bridge

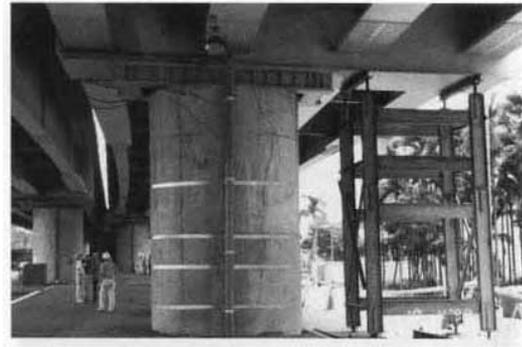
Fig. 23 Diagonal shear cracks at the column with eccentric connection

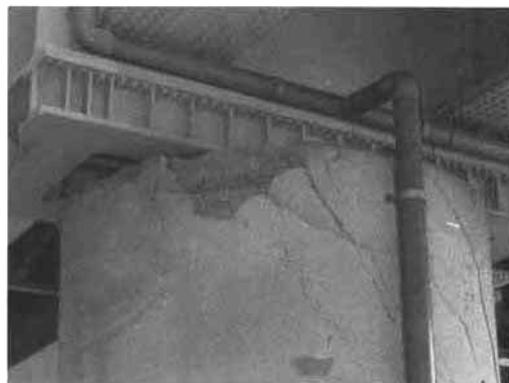
Fig. 24 Exposed confinements of a column with eccentric connection

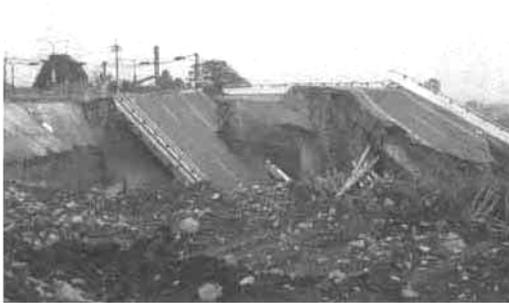
southern abutment and nine spans collapsed as shown in Fig. 25. The first six piers extending from the southern abutment were tilted or fractured (Fig. 26). Moreover, the back-wall of the southern abutment was cracked by the superstructure and thus was driven back into the back-fill (Fig. 27) under the strong longitudinal ground shaking.

From the field observation, ground rupture may be responsible for those tilted piers and collapse of the northern segments. However, the collapse of the spans in the southern segment appears to be induced by the enormous impact of the superstructure on the back-wall.

Fig. 25 Collapsed spans of the Ming-tsu bridge

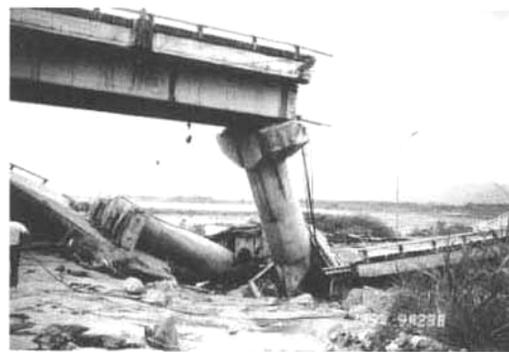
Fig. 26 Tilted or fractured column bents of the Ming-tsu bridge

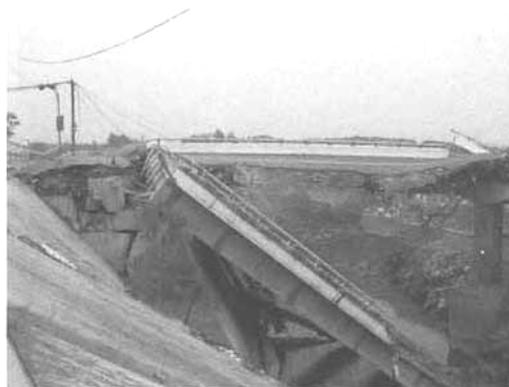
Fig. 27 Cracked back-wall of the southern abutment

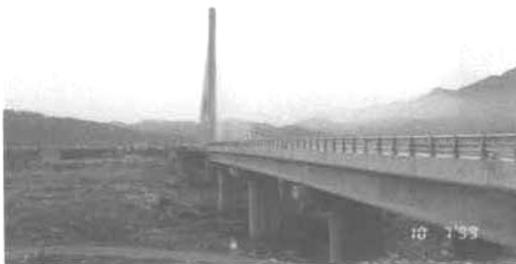
Fig. 28 The cable-stayed Ji-lu bridge

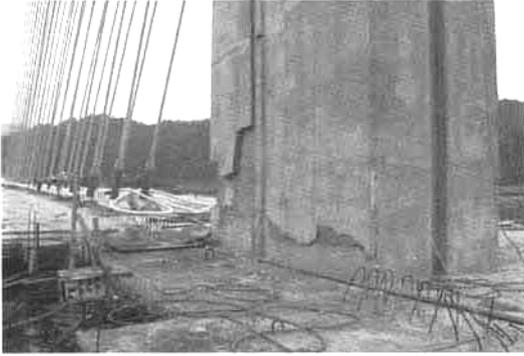
This bridge is very close to the epicenter, and the horizontal PGA measured nearby is about 600 gal and 400 gal in the transverse and longitudinal directions, respectively. Such enormous ground shaking may have been responsible for the relative movement of certain adjacent spans and for unseating of the approach span. Moreover, since there is an uninstalled cantilevered section at the base of the tower, the transverse vibration of the cable-stayed bridge may have been unsymmetrical about the longitudinal centerline of it. Thus, damage to both the parallel faces of the tower to the longitudinal direction is unsymmetrical and the connection at the base of the tower to the superstructure was crushed due to stress discontinuity.

Fig. 29 Concrete spalled off and horizontal cracks at the tower base

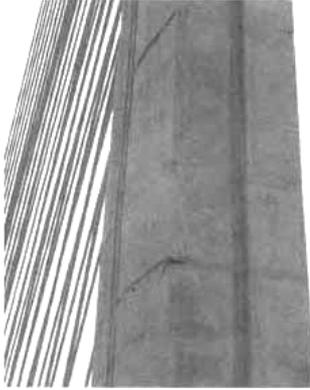
Fig. 30 Vertical split along the tower height

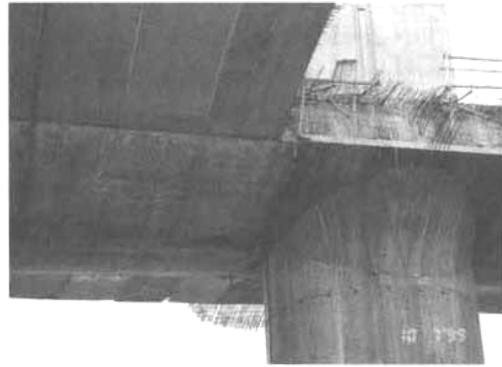
The Ji-lu bridge is a cable-stayed bridge with two 120m spans and a single tower (Fig. 28). The tower, constructed with reinforced concrete, is 58m high and sustains the prestressed concrete superstructure by 17 pairs of parallel steel cables from each side of it. Each end of the cable-stayed bridge is connected to a simply-supported approach span. At the time of the earthquake, this bridge was almost completed except for the guard rails and a cantilevered section of the superstructure at the base of the tower. The tower, superstructure, and some cables experienced significant damage. As shown in Fig. 29, concrete at the base of the tower was spalled off and some horizontal cracks occurred. At the same face of the tower and extending from where concrete was spalled off, vertical splits along the tower height were observed (Fig. 30). Nevertheless, damage to the opposite face of the tower was not as severe. Furthermore, the connection between the tower and the superstructure at its base was smashed (Fig. 31). Similar damage was observed at the end of the superstructure on the

Fig. 31 Crush at the connection between the tower and the superstructure

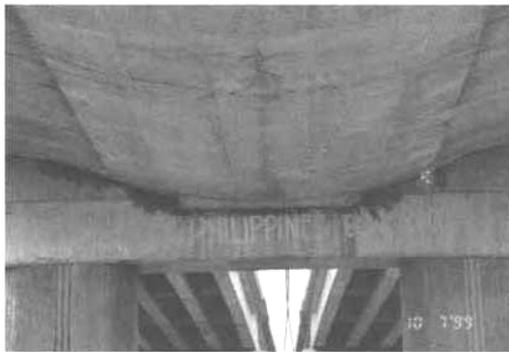
pier of the approach span, as shown in Fig. 32. The approach span was unseated from its elastomeric pads and the associated pedestals under the strong transverse ground motion (Fig. 33), and relative movement between certain adjacent spans was observed (Fig. 34). In addition, one of those 68 cables was torn off from its restrainer, as shown in Fig. 35.

Fig. 32 Crush at the connection between the cable-stayed and approach spans

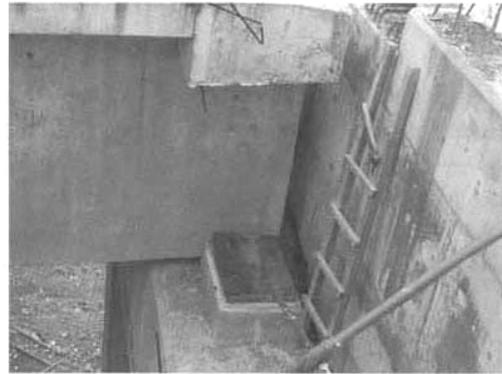
Fig. 33 Unseated approach span from its bearing

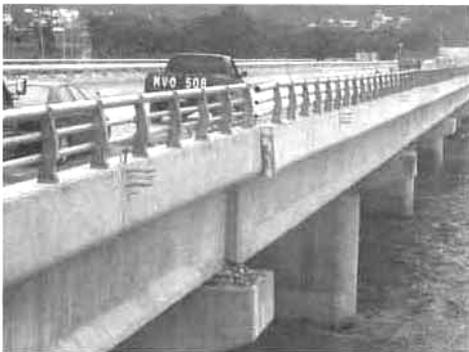
Fig. 34 Relative transverse movement between adjacent spans

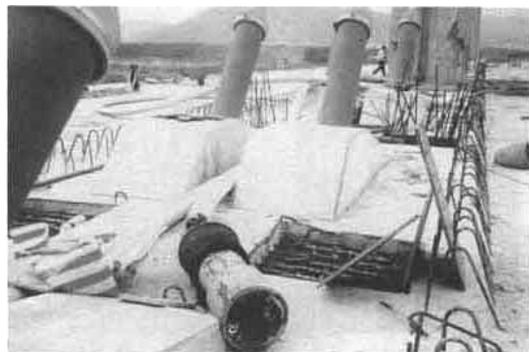
Fig. 35 The torn-off cable from its anchorage

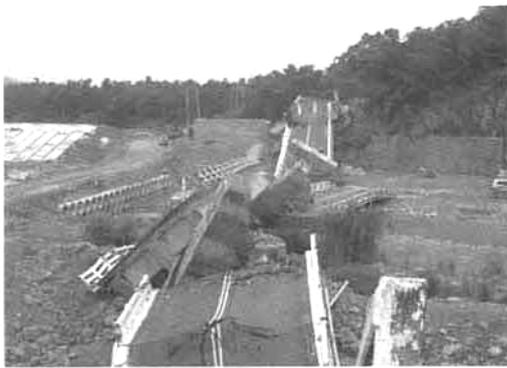
Fig. 36 A view on the collapsed Tong-tou bridge

Since the columns and spans collapsed in an unsymmetrical scenario, it appears that they did not fail at the same instant. Extending from the northern abutment, the first column was snapped to the east, while the other two were snapped to the west. The north end of the second span rotated clockwise about its south end, while the whole third span was tilted to the west and partially lay on the caps of both fractured columns. It seems that the northernmost column was destroyed one moment before the others. Moreover, because those two spans close to the abutments still stayed at the longitudinal centerline after their collapse, it seems that they failed a moment before the columns did.

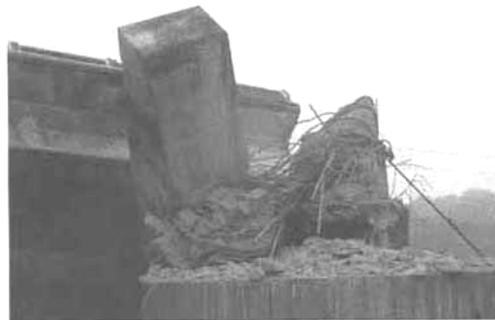
generally the longitudinal direction, and 360 gal in the other direction. During the earthquake, all three single circular columns were cut off by shear failure (Fig. 37) and the spans collapsed. It was noticed that those large-diameter caissons extended well above the riverbed and thus reduced the relative height of each circular column to the overall height of both the column and its caisson. Both abutments were damaged, with the northern one impacted into its back-fill and crushed severely, as shown in Fig. 38. Furthermore, significant settlement of the northern approach slab occurred (Fig. 39).

Fig. 37 Shear failure of the single circular column

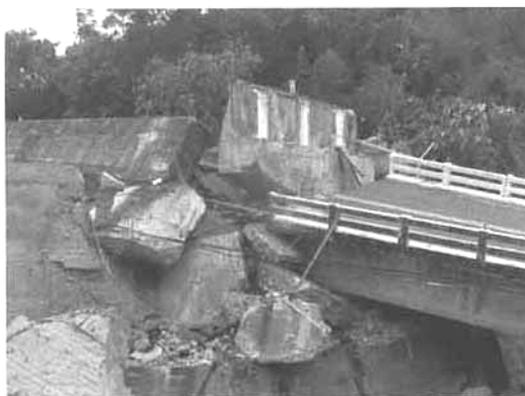
Fig. 38 The crushed northern abutment of the Tong-tou bridge

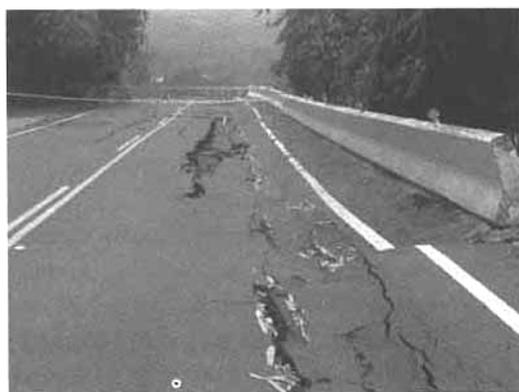
Fig. 39 Settlement of the approach slab of the northern abutment

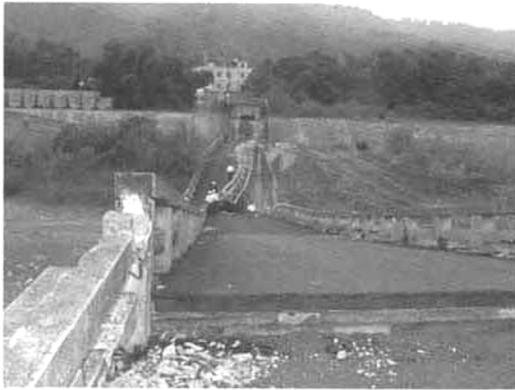
Fig. 40 Collapse of two spans of the Long-men bridge

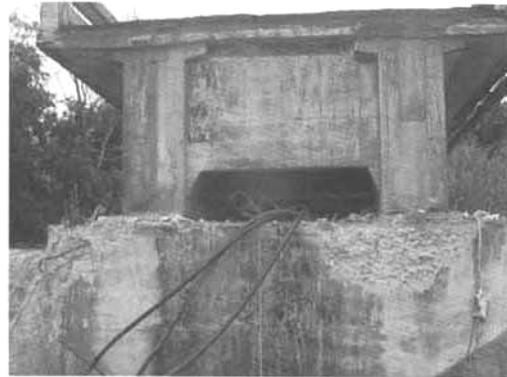
The 12-span, simply-supported Long-men bridge was completed in 1982 and is located on Tou-53 Route. It comprises 2 prestressed, reinforced concrete girders with a span length of 40 meters as the superstructure and single column bents on caissons as the substructure. Under the earthquake excitation, the second and third spans extending from the western abutment collapsed (Fig. 40). Since there is no significant damage to other structural components, it appears that no unseat prevention device (Fig. 41) may have been the reason for its collapse.

Fig. 41 No unseat prevention device between adjacent spans

Furthermore, unseating prevention devices and sufficient seat widths should be provided to protect from unintended strikes. Ground failure, skewed spans, and liquefaction, *etc.*, may induce additional structural movements, such as the Shi-wei bridge. Well-designed shear keys, restrainers, and concrete stoppers are excellent equipment for unseating prevention. Also, as noticed in the field observation, the span next to either abutment collapsed in all those bridges with collapsed spans. Thus, adequate design and construction of abutment back-walls and fill-backs are essential even for continuous spans.

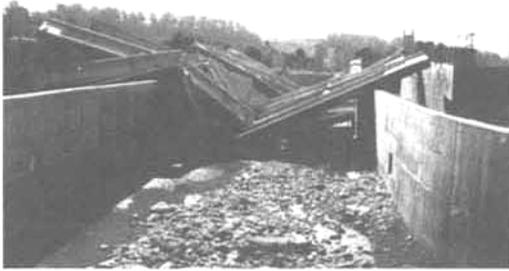
damage to those bridges is the fracture or tumbling of the uninstalled, cast-in-place, reinforced concrete girders, as shown in Fig. 42(a) and Fig. 42(b). The Feng-yuan viaduct, which is located at the Taichung Branch of the Second Freeway, suffered moderate damage to the elastomeric bearing systems. Many bearing pedestals of steel pot bearings were crushed during the earthquake (Fig.

Fig. 42(a) Fracture of uninstalled, cast-in-place, concrete girders

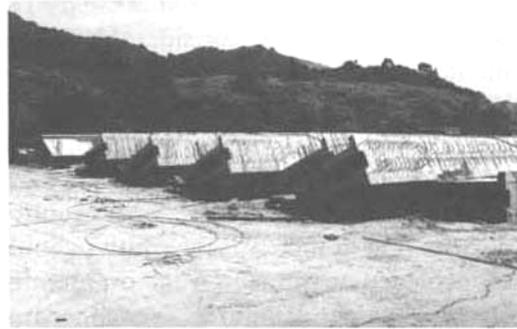
Fig. 42(b) Tumbling of uninstalled, cast-in-place, concrete girders

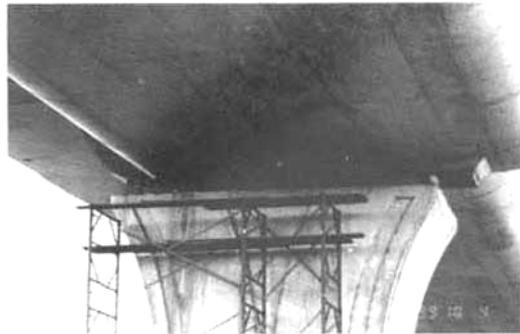
43) and the box girders supported by them exhibited a permanent transverse dislocation (Fig. 44).

Fig. 44 Transverse movement of the superstructure
