Overview of Building Damages in 921 Chi-Chi Earthquake

K.C. Tsai ¹⁾ Chiang Pi Hsiao ²⁾ Michel Bruneau ³⁾

ABSTRACT

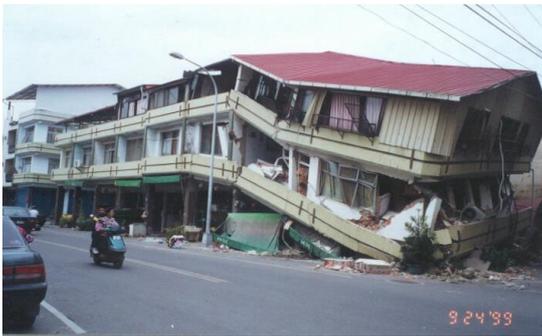
ed non-ductile reinforcing details compounded by detrimental building configurations. A large percentage of buildings that collapsed due to the main shock or strong aftershocks are old unreinforced clay block masonry cottages and non-engineered and one-to-three stories reinforced concrete frame structures constructed with brick in-fill partitions and exterior walls. Many collapsed buildings had a pedestrian corridor and open front at the ground floor, and only one wall at the back of the building along the street direction

(Photo 1). This type of building damage accounts for the majority of the complete building collapses near the epicenter due to severe ground shakings. Many school buildings suffered extensive and severe damages. The “short-column” type of damage in these reinforced concrete structures is rather common in the direction parallel to the exterior corridor outside the classrooms where windows above half-height in-fill shortened the effective length of almost all the columns (Photo 2).

Photo 1 Collapse of the typical building having pedestrian corridor

3. The extensive vulnerability of the existing building inventory, as revealed by this earthquake, must be addressed before other equally destructive earthquakes strike again in the country. A particular attention should be paid to buildings having soft stories and open front. This requires the establishment of priorities, timetable, policies and criteria for seismic retrofit. It is not fiscally possible to retrofit all structures in cities having extensive building inventories, but key post-emergency building (such as hospitals and other critical facilities) require special measures to ensure that they will be made available.

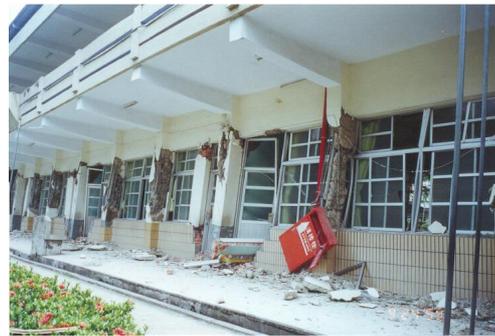
Photo 2 Shear failure of RC columns due to the short column effect

4. In light of the damages observed in the school buildings, it is recommended that the lateral force resisting system in the direction parallel to the exterior corridor for new school buildings be carefully configured in order to avoid the occurrence of "short column" brittle failure mode. The observed damages also suggest the urgent need of retrofitting the existing vulnerable school buildings.

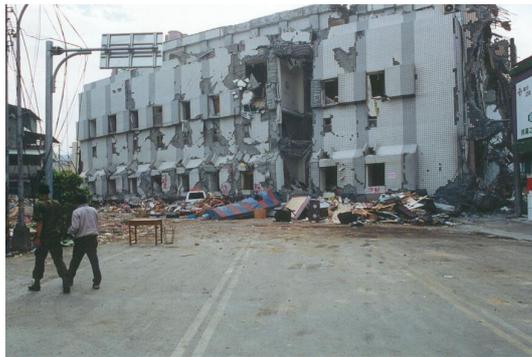
However, in the affected area, more than two dozen modern 10-to-20 stories apartment buildings overturned or collapsed. These were reinforced concrete moment resisting frames, most of them constructed with cast-in-place 15cm thick exterior wall and 12cm thick partition walls (Photo 3). The observed damages on reinforced concrete structures suggested a large effect of masonry and lightly reinforced concrete nonstructural components. These buildings were typically designed following requirements for moment resisting

Photo 3 Collapse of a apartment building in Fengyuan

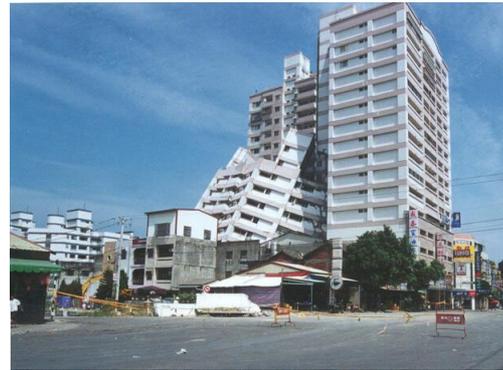
exhibited evidence of ductile detailing. Many of them appear to have tall floor and open plaza features in the ground level. Commonly encountered were failed columns with widely spaced stirrups (unconfined plastic hinge zone), splices with inadequate development length or located in the hinge region, light or in-existent joint transverse reinforcement, stirrups with 90°, etc. Strong-beam weak-columns systems apparently common, might have resulted in numerous story collapses following excessive column damage. This was particularly frequent in the first story of buildings, as the larger openings and higher story height there translate into a lower structural stiffness and strength, leading to "soft-story" mechanisms (photo 4).

Photo 4 Collapse of a high-rise apartment building in Dali
