Seismic Performance of Damaged Bridge Columns

An experimental study to evaluate repair techniques for damaged bridge columns was undertaken. The repair program consisted of four repair test specimens: three damaged to a severe level and one damaged to a moderate level. Repair schemes for the severely damaged columns used headed reinforcement and mechanical couplers. The moderately damaged column was repaired by cover replacement and epoxy injection. The success of each scheme is evaluated by comparing behavior of the repaired column with that of the original column.

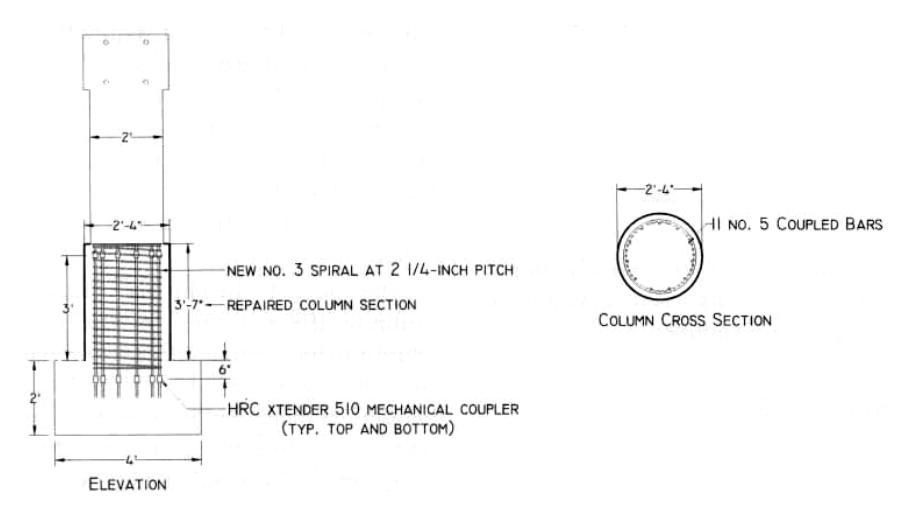
Fig. 3 Column 407R repair design

Column damage included cover spalling to approximately half the column diameter. Maximum crushing of column core and anchor block was limited to 2.5-inch depth. Of the 11 column longitudinal bars, five fractured following bar buckling and two buckled without fracture. The spiral reinforcement in the spalled region fractured at several locations.

Details of the repair scheme are shown in Fig. 3. A 3-foot section of the column was removed. To achieve this, the column was mechanically severed at the interface and 3 feet above the anchor block and removed. Repair of the joint included removing the loose concrete in the joint region and 6 inches of the longitudinal bars anchored into the joint, approximately equivalent to ten bar diameters.

Following demolition, the remaining portion of the existing column longitudinal reinforcement was connected to the longitudinal reinforcement in the anchor block using mechanical couplers. The repaired portion of the column was tied with new spiral reinforcement, having 3/8-inch diameter spiral at 2 1/4-inch pitch; thus, the resulting reinforcement ratio is equivalent to the original column. Accessibility to the column core during casting required the column be recast to a diameter 4 inches larger than the original column resulting in a cover dimension of $2 \ 3/4$ -inches.

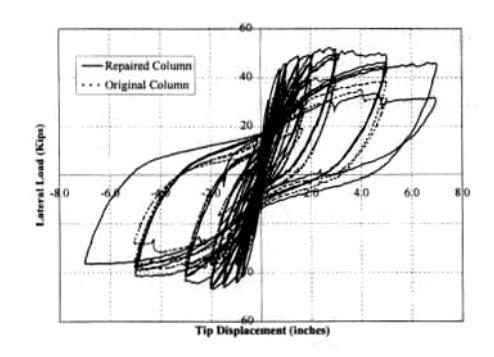
Fig. 4 Column 407R force-displacement response comparison of virgin *vs.* repaired response

shown in Fig. 4. The response of the repaired specimen was similar to the original with a slight increase in strength and stiffness due to the increased concrete cover. Strength decrease resulted from cover spalling on the repaired specimen. The post-spalling strength tended towards the strength of the original specimen, as expected. The ultimate and yield displacements of the repaired column were greater than the corresponding quantities in the original The resulting displacement column. ductilities were comparable.

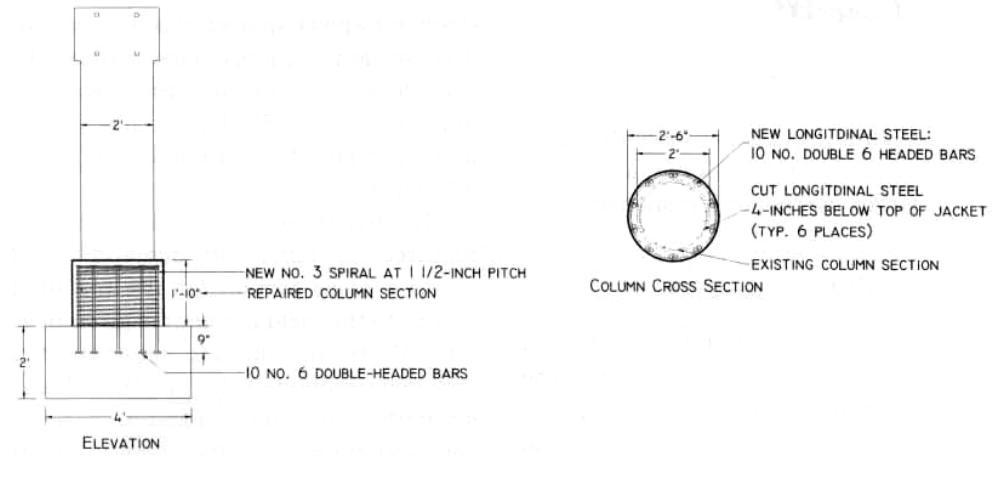
Fig. 5 Column 415SR repair design

column cover up to 18 inches, crushed core concrete to a depth of 7 inches, anchor block damage to a depth of 2 inches below the interface, and significant cracking throughout the column height. All of the 22 column longitudinal bars had buckled and nine had fractured. Steel damage was more pronounced on one side of the column; seven longitudinal bars and three levels of spirals had fractured as a result of the additional actuator movement.

The repair scheme is shown in Fig. 5. The damaged concrete was removed from the lower 22 inches of column height and from the anchor block surrounding the column perimeter. Holes were drilled into the anchor block at the locations of the new headed bars. The damaged spiral was removed from the lower 10 inches of column height. Six of the existing longitudinal bars were cut four inches below the top of the new concrete jacket. The remaining fractured bars were repaired with welded lap splices.

Following demolition, ten headed longitudinal bars were grouted into the anchor block with a high strength grout (Chem-75). No. 3 ($^{3}/_{8}$ -inch diameter) spiral reinforcement was placed in the jacketed region at $1 \frac{1}{2}$ -inch pitch, with 2 levels of spiral at the top to prevent kick-out of the top head. The concrete jacket was cast, and the existing cracks in the hinging region were injected with epoxy.

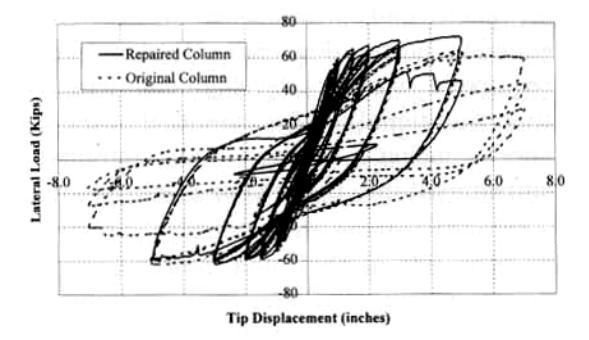
Fig. 6 Column 415SR force-displacement response comparison of virgin *vs.* repaired response

As designed, the inelastic action was restricted above the height of the concrete jacket. The force-displacement response for the original and repaired columns is shown in Fig. 6. The decreased moment capacity at the new hinge resulted in the original column strength with no increase in the shear demand. The decrease in the effective height, resulted in an increase in the column stiffness and a

decrease in both the displacement capacity and the displacement ductility for the repaired column.

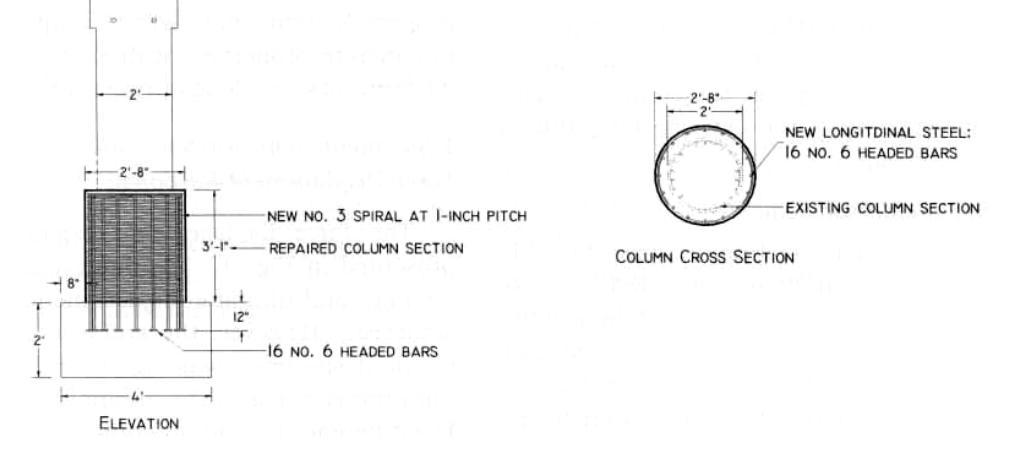
Fig. 7 Column 430R repair design

Observations of column concrete damage following testing include cover spalling to a height exceeding half the column diameter (13 to 15 inches), and crushing of column core to 8 inches. Damage to the anchor block included concrete spalling at the column face approximately 2 feet long and 4 inches wide with maximum depth of 1 inch. Of the 44 longitudinal reinforcing bars, all buckled and none fractured. The buckled length ranged from 3 to 6 tie spacings (4 to 8 inches).

Figure 7 shows the final jacket dimensions. Using the above expressions, the final jacket dimensions were determined to be 32 inches in diameter and 3 feet in height (the dimensions satisfy the three expressions with a factor-of-safety of 1.33). The headed bars were embedded 12 inches into the joint.

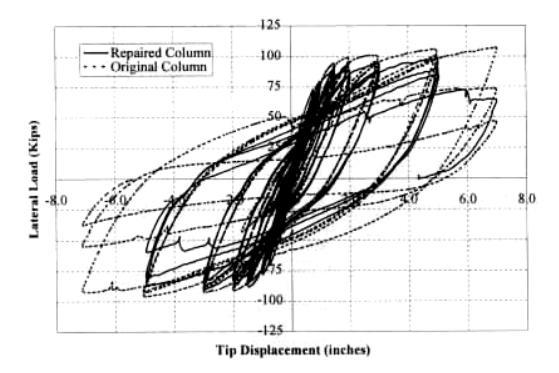
Fig. 8 Column 430R force-displacement response comparison of virgin vs. repaired response

Figure 8 presents the force-displacement response of the original and repaired specimens. The repair scheme achieved the performance objectives. There was a slight increase in the initial stiffness of the repaired specimen and the ultimate moment capacity was slightly less than the original column. The low longitudinal reinforcement ratio of the repaired specimen resulted in earlier exhaustion of the tensile strain capacity of the steel, limiting the displacement capacity of the repaired specimen to 5 inches (compared with 7 inches for the original column). However, the displacement ductility capacity of the two specimens was comparable.

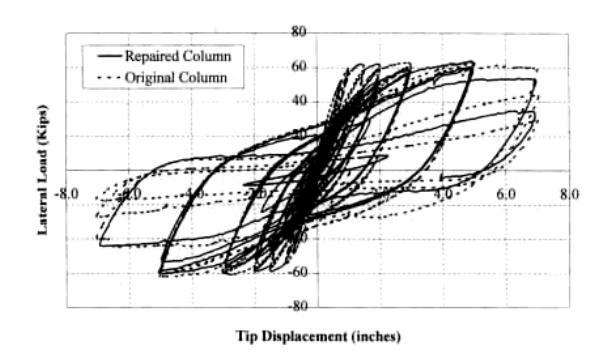
The force-displacement response is presented in Fig. 9. The same ultimate strength and ultimate displacement were achieved. However, the stiffness of the required specimen was significantly less than the stiffness of the original column. The difference in column stiffness may be due to a number of factors including: the

existence of cracks above the hinge region that could not be injected, an inability to penetrate epoxy into the core concrete of the hinge region, crushed concrete within the core of the hinge region, previously yielded reinforcing steel, or degradation of bond into the anchor block.

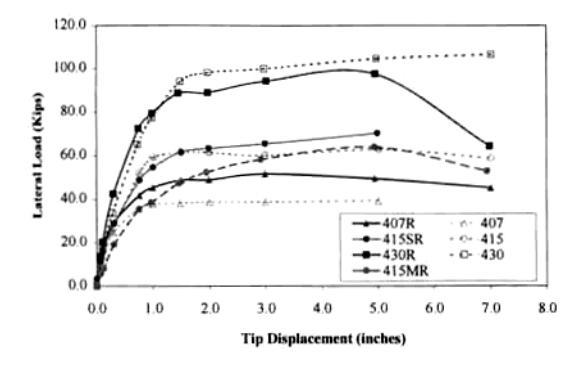
Fig. 10 Force-displacement envelopes

The experimental force-displacement envelopes of the original and repaired columns are shown in Fig. 10. А comparison of the three severely damaged columns shows the repaired columns all had the same or greater stiffness than the original specimens. The repaired strength was within 10% of the original strength for all columns. The deformability of the repaired specimens, with respect to the original columns varied. In the case of 415SR and 430R, the deformation capacity was less. The deformation capacity of column 407R exceeded that of the original specimen.

Comparing the response of 415MR, the moderately damaged column, and 415SR, the severely damaged column with that of the original column provides interesting results. The initial stiffness of the moderately damaged specimen was significantly less than the original. However, the strength and deformability of the repaired specimen was equal to the original. The response of 415SR is markedly different than 415MR. The initial stiffness and strength of the column closely matched the original behavior; however, the displacement capacity was less.
