Preliminary Investigation of Damage to Near Fault Buildings of the 1999 Chi-Chi Earthquake

Cheng-Cheng Chen¹⁾ Ching-Tung Huang²⁾ Rwey-Hua Cherng¹⁾ Van Jeng¹⁾

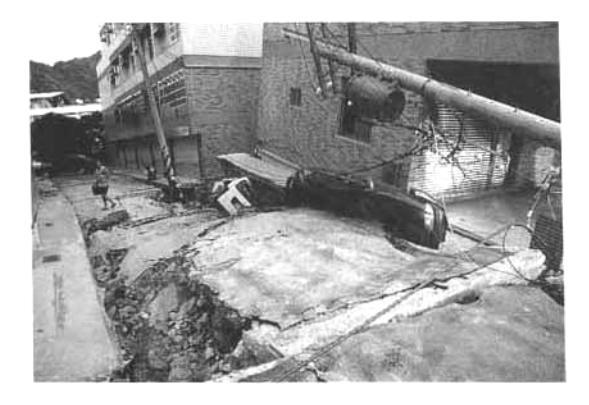
Tremendous ground movement and surface fault of the Chelungpu fault damaged streets, severely building foundations, electric poles, and even vehicles parked on the street, as shown in The vertical offset of the Fig. 6. Chelungpu surface faulting can be as high as 5m (Fig. 7). As surface faulting passed through multi-house buildings, enormous ground settlement severely damaged the structures, as shown in Fig. 8. As surface faulting cut through the edge of a multi-house building (Fig. 9), the edge house did not deform as intensely as the building shown in Fig. 8 due to the constraint provided by the neighboring houses. However, the ground floor pavement of the edge house (the one marked with an arrow in Fig. 9) was pushed up and squeezed all objects in the first story against the second floor slab, and consequently, caused casualties in the first story. Figure 10 shows a multihouse building sitting on the fault line with its larger plane dimension parallel to

Fig. 6 Damage caused by ground movement and breakage

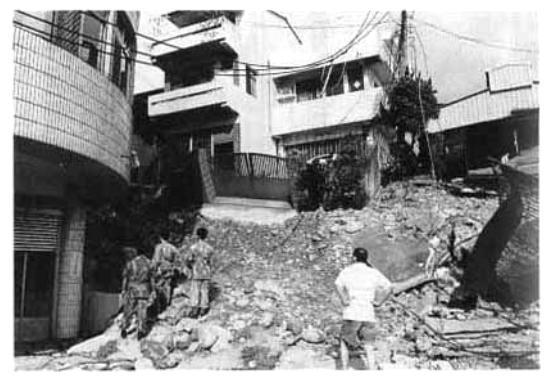
Fig. 7 Vertical offset of Chelyngpu surface faulting

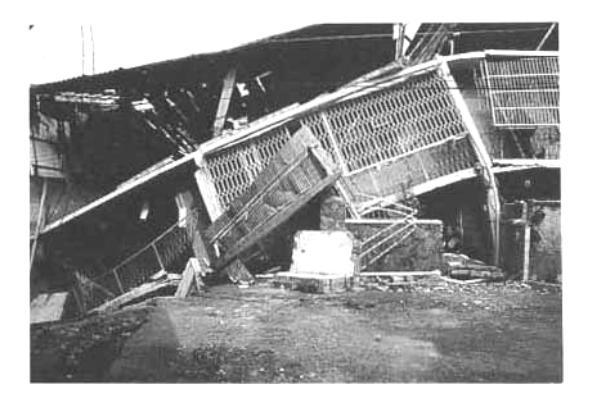
Fig. 8 Multi-house building damaged due to surface faulting

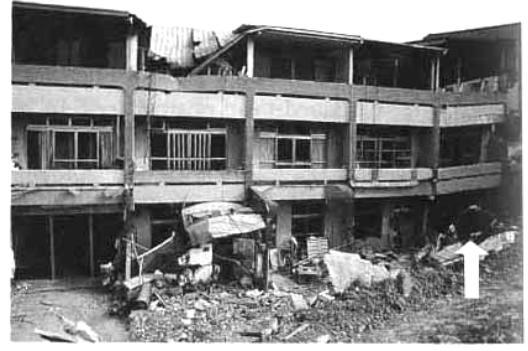
Fig. 9 Multi-house building damaged due to surface faulting and uplifting of ground floor paverment

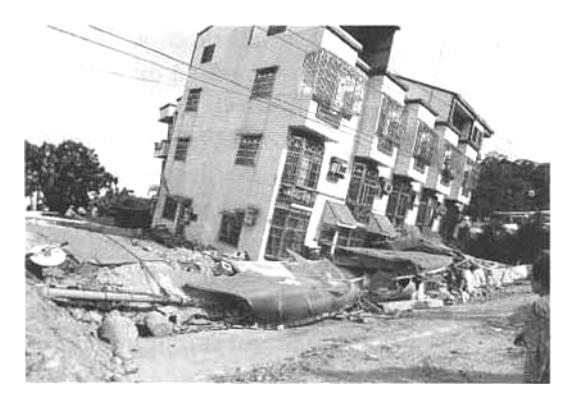
the fault line. Although the building also underwent foundation damage, structural damage, and ground floor pavement breakage, surface faulting did not cause excessive and life-threatening uplifting of the ground floor pavement.

Fig. 10 Damage to multi-house building with larger plane dimension parallel to fault line

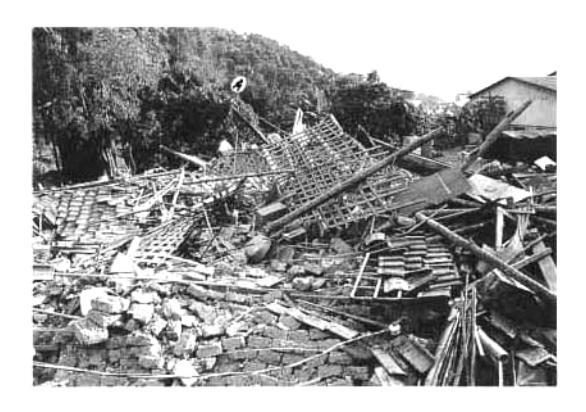
Unreinforced brick buildings and clay block buildings (Fig. 11), which are susceptible to tensile stress, collapsed as surface faulting passed through or passed by. Low-rise light-gage steel buildings (Fig. 12) were too flexible to cope with the severe ground settlement as well as breakage, and collapsed as surface faulting passed through.

Fig. 11 Collapse of clay-block building

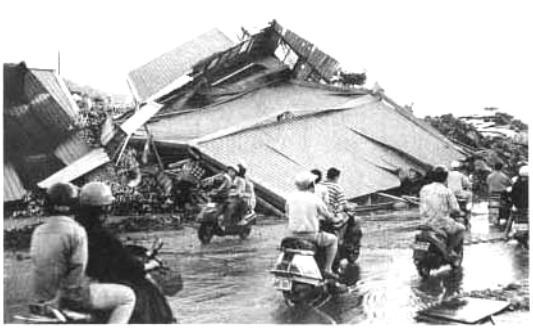
Fig. 12 Collapse of light-gage steel building

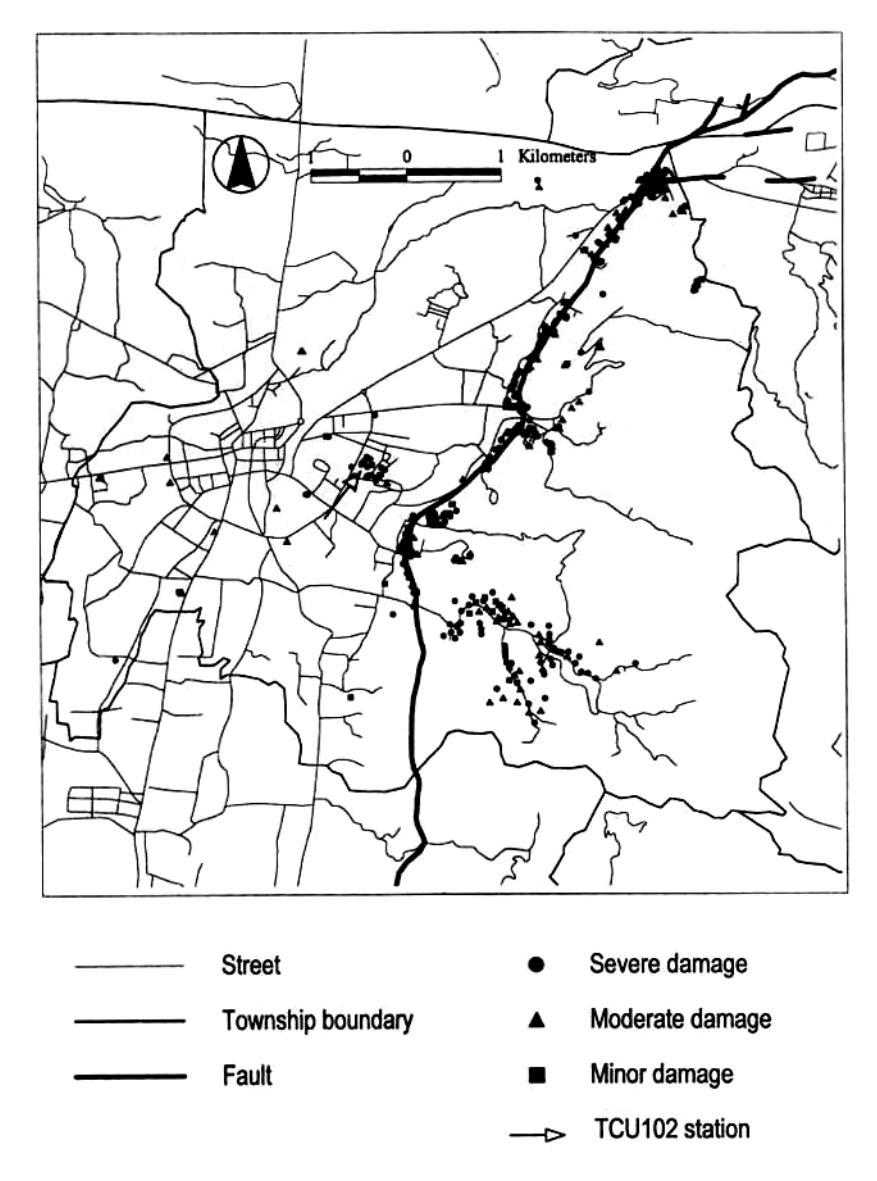
Fig. 13 Damage distribution to buildings in Fengyuan (prepared by the architecture and building reaearch institute)

total of 552 buildings were А evaluated as damaged, as shown in Fig. 13. Sixty three percent of the damaged buildings were reinforced concrete (RC) buildings, as listed in Table 2. The vast majorities of RC buildings in Fengyuan use moment-resisting frames as lateralforce-resisting systems. For RC buildings that were 5 stories or lower, brick walls are used as exterior walls and interior partitions. For those that are 6 stories or higher, 15cm thick RC walls are used as exterior walls, and brick walls or brick walls along with 12cm thick RC walls are used as interior partitions.

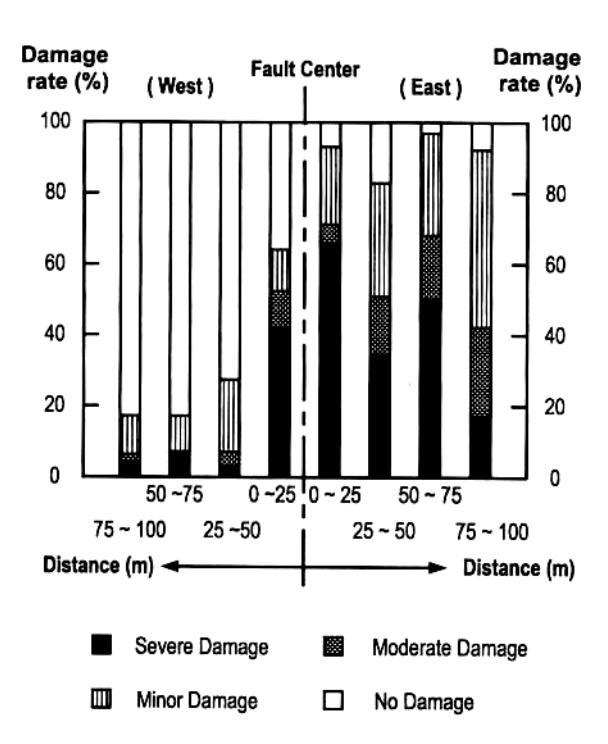
Figure 16 shows the damage rate distribution to buildings in the fault area. Most of the building damage in the first 25m was associated with surface faulting, whereas the damage to buildings within 25 to 100m was primarily due to ground shaking. The damage rate associated with ground shaking was considerably

higher in the east fault area than the west fault area. Both the average damage rate and the damage rate distribution in the fault area indicate that the ground shaking on the hanging-wall was much more destructive than that on the footwall.

Fig. 16 Damage rate distribution to buildings in fault area
