# 國道高速公路橋梁耐震補強 第2期工程(第1優先路段)規劃設計

## 中華民國地震工程學會-結構耐震補強技術獎

### 簡報

**TY-LIN** INTERNATIONAL TAIWAN  
林同棪工程顧問股份有限公司

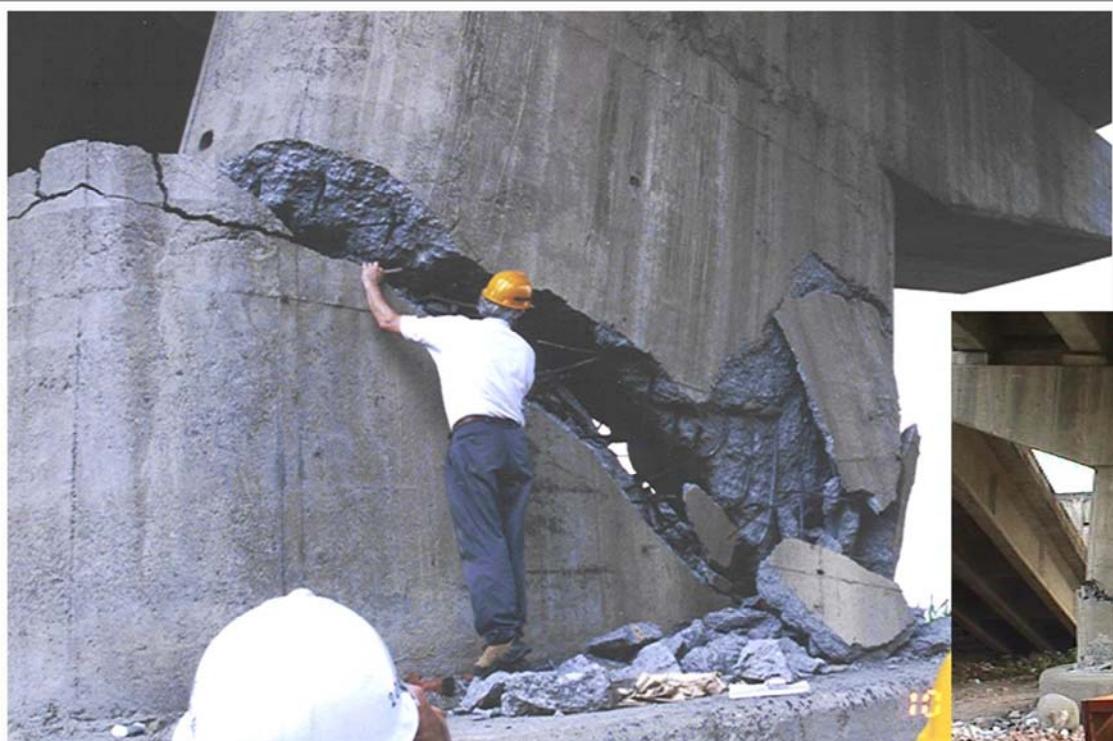
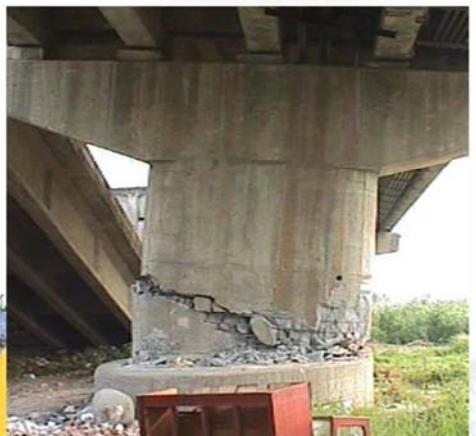
Shear failure in pier of Wu-Shi bridge, Chi-Chi Earthquake,  
Taiwan, September 1999

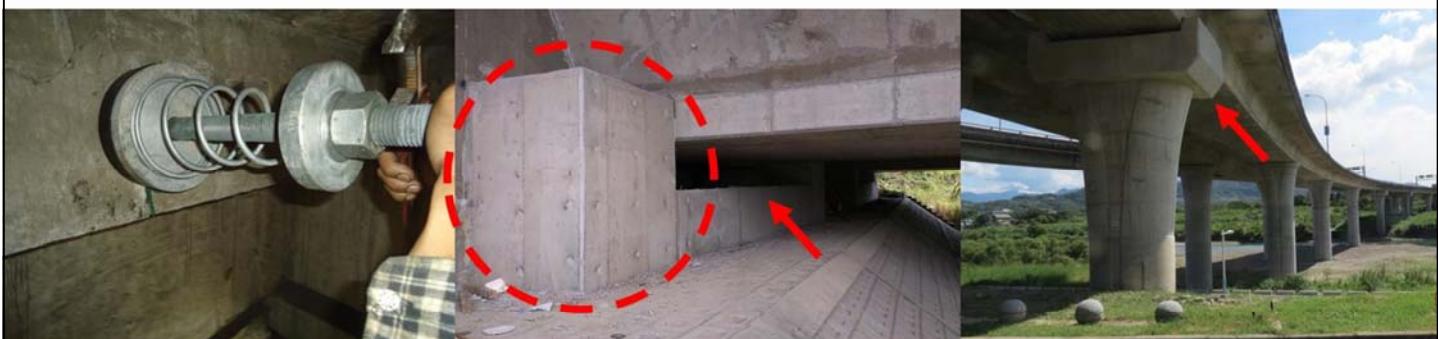
## Bearing seat extension, restrainer and shear key

Seismic Restrainer

Bearing seat extension and RC shear key

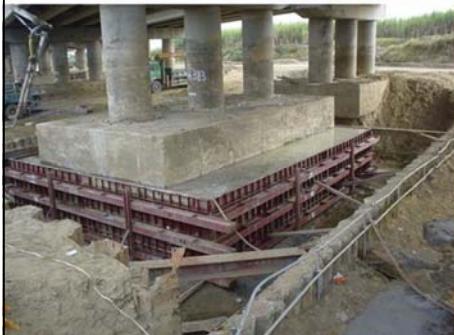
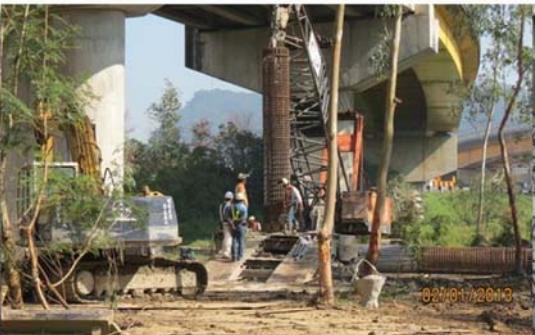
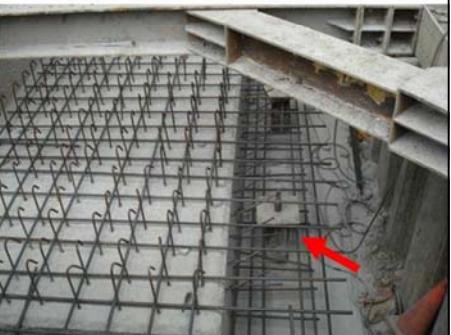
## Footing retrofit and replacement

Footing retrofit with supplemental piles (CIDH, CISS piles)

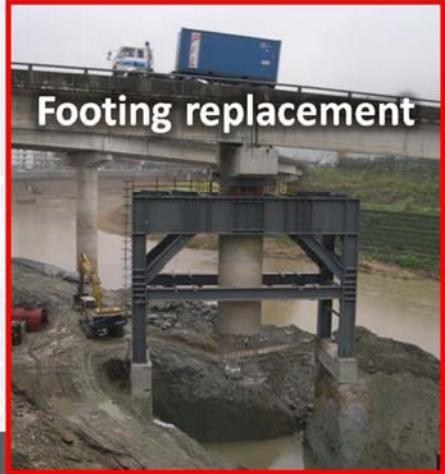
Footing replacement

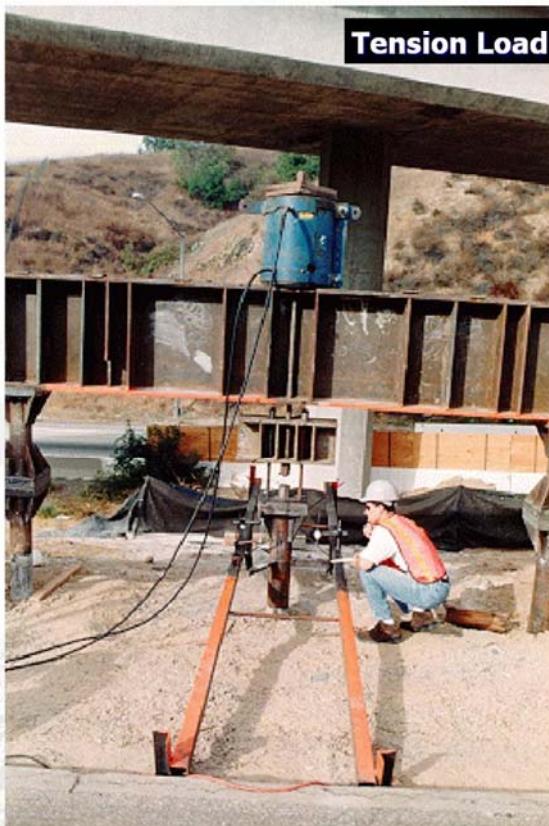
## 現場載重試驗 (Load Test)

Tension Load
