Chi-Chi Earthquake Induced Landslides in Taiwan

ABSTRACT

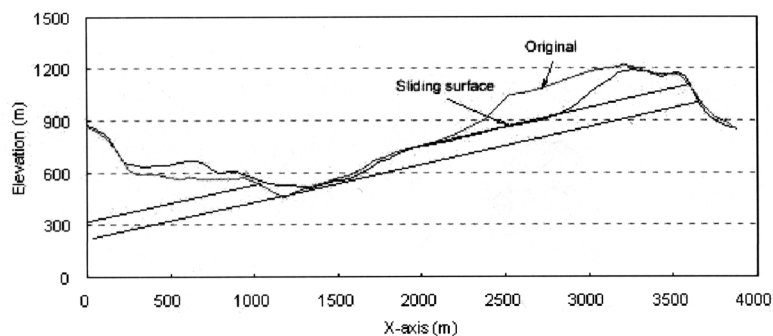
Fig. 6 The central profile of the 1999 (21st September) Tsao-Ling rockslide event (Courtesy of Professor Lin, Meei-Ling and Dr. Chen, Tien-Chien)

During the 21st September 1999 Chi-Chi earthquake ($M = 7.3$, CWB scale) event, a rock mass of about 120-million cubic meters slid down the Tsao-Ling dip slope. A schematic central profile is shown in Fig. 5. Figure 6 shows the central profile of the dip slope after the slide. The remaining dip slope consists of 4 steps (scarps). The dip angle measured on different steps of the dip slope ranges from 12 degrees to 14 degrees. Only 20% (about 25-million cubic meters) of the sliding mass dropped into the valley of the Ching-Shui River. Most of the sliding mass (of about 100-million cubic meters), and 39 people (36 residents and 3 visitors) who lived behind the crest (called Crest Forever) of the dip slope, flew over the Ching-Shui River, and landed on top of the remaining part of the old landslide dam (called "Dao-Giao-Shan" by local people). 32 people were killed and 7 survived after the 'sliding-flying-landing'

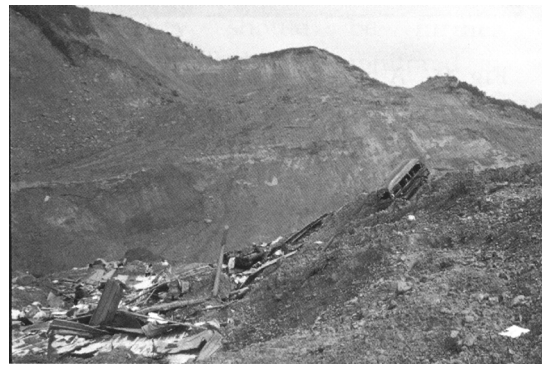
Fig. 7 A photograph which telling the story of a flying mountain, Tsao-Ling

process. The wireless telephone in the van called Bao-Ma 747 (which traveled together with the 39 people) was used to report their situations to the office of Tsao-Ling Village. Figure 7 tells the story. Another 4 people in a lower corner of the dip slope were also killed. Stripping of a few hill-slopes downstream of the landslide dam has been observed. Air-blast or release of compressed air cushion under the sliding mass might be responsible for it. The Chin-Shui River was once again dammed after the sliding. The volume of the dam-up lake is about 45-million cubic meters. The straight-line length of the landslide dam measured 4 kilometers from upstream heel to downstream toe. The curved plug length of the Ching-Shui River channel is about 5 kilometers. The plug height of the Ching-Shui River valley is only 50 meters, which is much lower than that of the new Dao-Giao-Shan. Figure 8 is the satellite (Spot) image of Tsao-Ling area on 27th September 1999. Figure 9 is a photo showing (from left to right) a part of the Dao-Giao-Shan, the dammed valley of Ching-Shui River, and the lower section of the remaining dip slope, looking from the southeast, on 28th November 1999. The plugged section of the Ching-Shui River channel was modified (rip-rap, bulldozing, etc.) to allow for smooth and safe passage of the overflow that commenced on 22nd December 1999. Check dams are also constructed in the downstream sections of Ching-Shui River for safeguarding the people and the lands from being smashed by possible debris flow due to sudden break of the landslide dam. Figure 10 is a photo showing the bird's eye view of Tsao-Ling area on 29th June 2000. Direct field observation and photographs taken from the air (such as Fig. 10) have proved the existence of

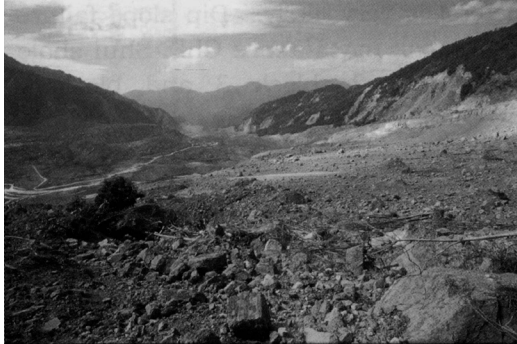
Fig. 9 A part of the Dao-Giao-Shan, the dammed channel of Ching-Shui River, and the lower section of the remaining dip slope, looking from the southeast, 28th November 1999
