Seismic Performance of Passenger Elevators in Taiwan

George C. Yao ¹⁾

*1) Department of Architecture, National Cheng Kung University, Tainan, Taiwan
701, R.O.C.*

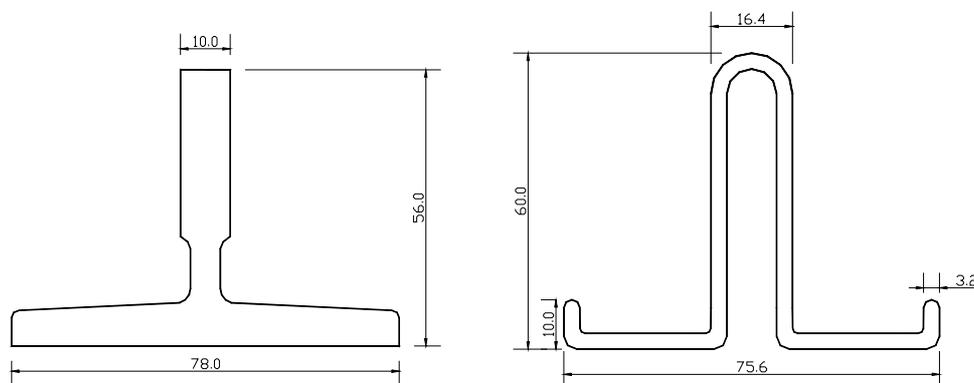
Fig. 4 CW rail size comparison

to the large high frequency contents in the 1022 earthquake comparing to the 921 quake, as shown in Fig. 3. The frequency components above 10Hz is richer in the 1022 data. The flexible CW system has a low natural frequency [4] and was not greatly magnified by the high PGA values rooted in the high frequency contents in the 1022 earthquake.
