Preliminary Investigation of Damage to Near Fault Buildings of the 1999 Chi-Chi Earthquake

Cheng-Cheng Chen¹⁾ Ching-Tung Huang²⁾ Rwey-Hua Cherng¹⁾ Van Jeng¹⁾

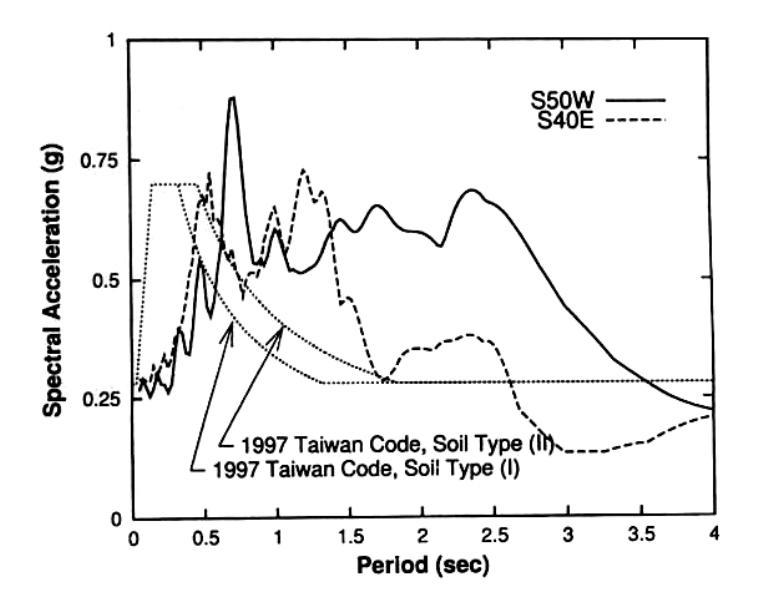
Fig. 14 Spectral acceleration record for TCU102 station

TCU102 station is the only strong motion station in Fengyuan and is about 0.8km away from the fault line (Fig. 13). Between ground surface and bedrock is a 15m-thick formation of gravel, and the soil condition is classified as type I. The ground motion and the corresponding spectral acceleration of the TCU102 record are shown in Fig. 3 and Fig. 14, respectively. In addition, the code (1997

Taiwan Code) specifications pertaining to design spectral acceleration for soils type I and soil type II are shown in Fig. 14. The PGA of TCU102 (S50W) is 251 gal, which is very close to the code specified acceleration of 0.28g. However, the spectral acceleration curves of the TCU102 record dramatically deviate from code specified curves. For periods shorter than 0.3sec, the TCU102 curves are much lower than code specified However, for periods between curves. 1.0 and 1.5sec, the TCU102 curves are much higher than code specified curves. In addition, the effect of ductility in reducing strength demand is much lower than expected for periods between 1.0 and 1.5sec, as shown by the dotted lines in Fig. 5. It is shown that the strength demand is higher than expected and the effect of ductility is lower than expected for buildings with periods falling between 1.0 and 1.5sec. Therefore, buildings that are 12 stories or higher suffered violent vibrations and were more vulnerable to the earthquake. However, it is

noted that all the buildings located beyond 1,200m away from the fault line were evaluated as either minor damage or no damage. This tends to suggest that the destructiveness of the ground motion declined for high-rise buildings that were 1,200m away from the fault line.
