Overview of Building Damages in 921 Chi-Chi Earthquake

K.C. Tsai ¹⁾ Chiang Pi Hsiao ²⁾ Michel Bruneau ³⁾

ABSTRACT

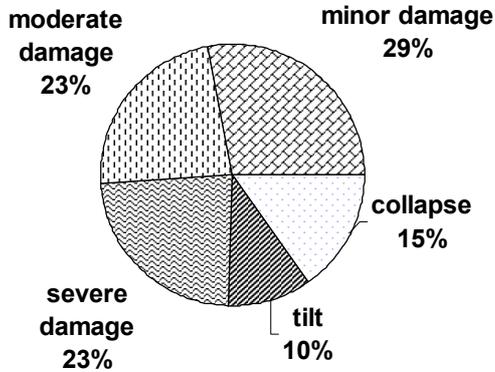
Fig. 9 Damaged percentage of RC structure

Due to the improvement of the construction technique in Taiwan, reinforced concrete structures become commonly constructed and represent a large portion of buildings. As the 921-earthquake damage survey indicates that the total number of the damaged reinforced concrete buildings has reached 4,325. Figure 9 indicates that 15% of the RC damaged buildings are the collapsed type, 10% of the damaged buildings are the tilted type, and 23% of the failures are the severely damaged type. The result indicates that over 48% of the RC damaged

structures are surveyed as severely damaged or more seriously damaged.

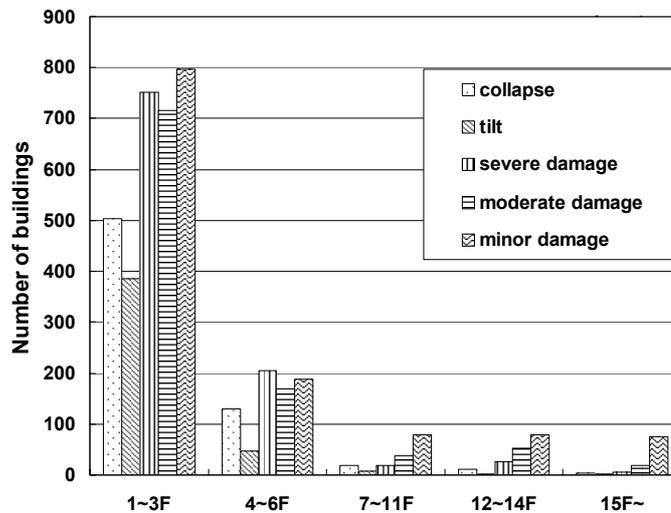
Fig. 10 Number of damaged RC structures with different number of stories

The 921 earthquake created a tremendous amount of damages in both Nantou and Taichung County. Since many low-rise single family houses are constructed and widely spread over these two areas; therefore, large numbers of low-rise buildings failures are recorded in this assessment. Figure 10 shows that about 75% of the damaged RC buildings are the 1 to 3-story buildings, and 52% of these damaged low-rise buildings are classified as the severely damaged. It was observed that 17% of the damaged

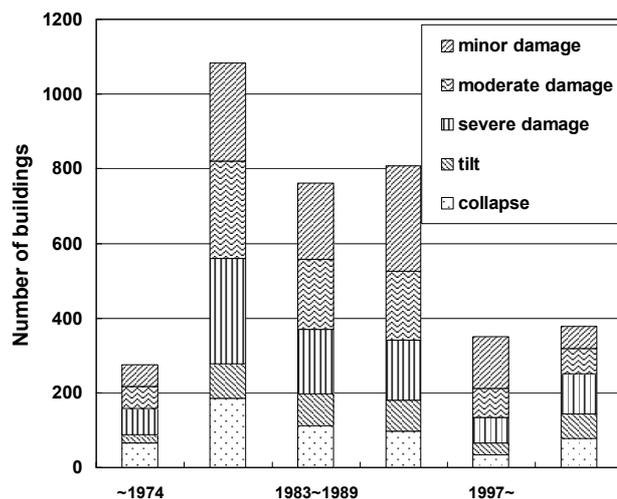
Fig. 11 Number of damaged RC structures with respect to construction periods

In order to find out the correlation between the structural damage level and the construction period, five construction periods are used in this survey: before 1974, 1975 to 1982, 1983 to 1989, 1990 to 1997, and after 1997. This breakdown can reflect the level of seismic design requirements prescribed by different versions of the design code. Figure 11 illustrates the damage level and the construction period of the damaged RC buildings. Since limited RC structures were constructed prior to 1974; therefore, roughly 7% of the total RC failures are constructed at that time.

In general, it was observed that the newly constructed buildings suffered a fewer damages. Approximately 30% of the RC damages were constructed between 1975 to 1982, and approximately 20% of damages were constructed between 1983 to 1989, and from 1990 to 1997. One exception is observed that the number of damaged buildings constructed during 1990 to 1997 is higher than the number of damaged buildings constructed during 1983 to 1989. In order to find out reasons, further investigations on the total number of buildings constructed in these two periods of time are required.

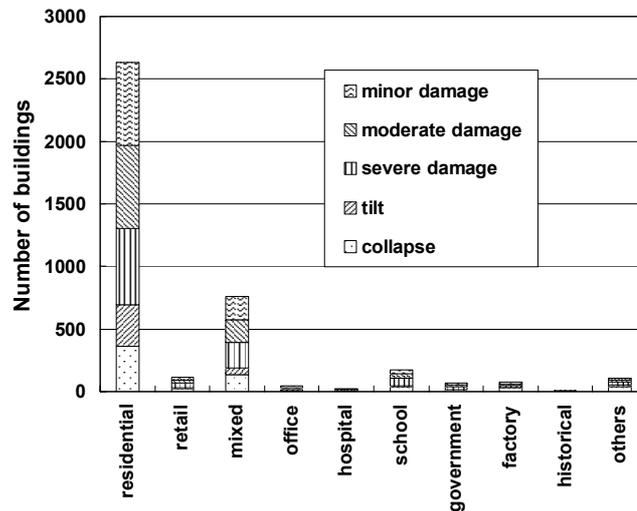
Fig. 12 Number of damaged RC structures with respect to building usage

In Taiwan, most of the buildings are constructed for the residential purpose, and a certain percentage of the buildings are the retail stores and the residential/commercial mixed buildings. In comparison, the historical buildings, the hospitals, and the offices are the minority. Figure 12 indicates that about 65% of the RC damages are the residential buildings, this high percentage of damages is related to their large constructed amount.

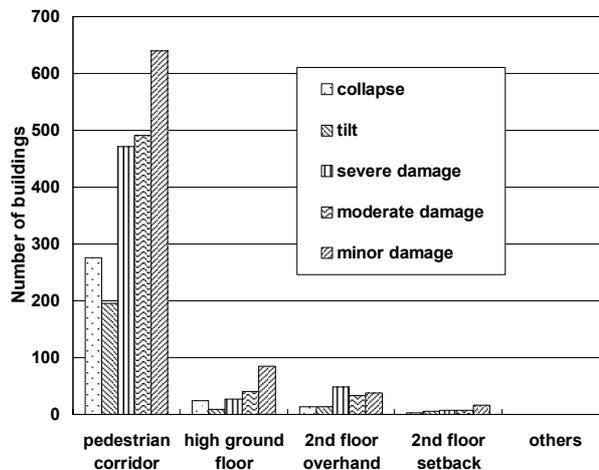
Fig. 13 Number of damaged RC structures with respect to vertical configuration
 Damage of the Un-reinforced Brick Building

Due to the long raining season in Taiwan, the Taiwanese developers commonly construct the buildings with the pedestrian corridor, and this popular style becomes a local practice and is prescribed in the building codes. Thus, the pedestrian corridor buildings represent a large portion of the failed structures, and experienced different

level of damages. Figure 13 indicates that approximately 84% of the RC damaged structures are the pedestrian corridor buildings, and roughly 45% of the pedestrian corridor buildings are classified as severely damaged or worse. The damage ratios of the other vertical configurations are relatively lesser. Approximately 7% of the damages are the buildings with a tall floor on ground level, 6% of the damages are the buildings with an overhang on the 2nd floor, and 1.5% of the damages are building with setback on the 2nd floor.

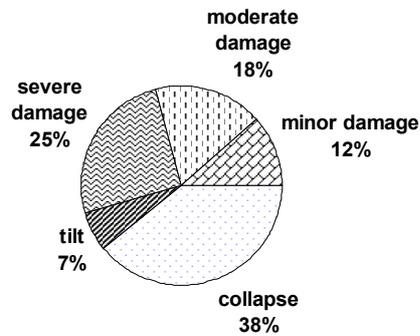
Fig. 14 Damaged percentage of brick structure

In the early agricultural age, the un-reinforced brick buildings were commonly constructed due to its low cost and simple manufactory. Because the un-reinforced brick block has a low seismic resistance, 2,014 un-reinforced brick building damages were recorded during this earthquake. The un-reinforced brick damaged buildings represent the second large group of the damaged structures. Figure 14 indicates that 1,428 damaged buildings, approximately 70% of the total damage, were classified as severely damaged or worse. The percentages of the damages for the collapsed buildings, the tilted buildings, and the severely damaged buildings are 38%, 7%, and 25% respectively. The poor seismic response and the brittle failure of the brick buildings had clearly illustrated during this earthquake.

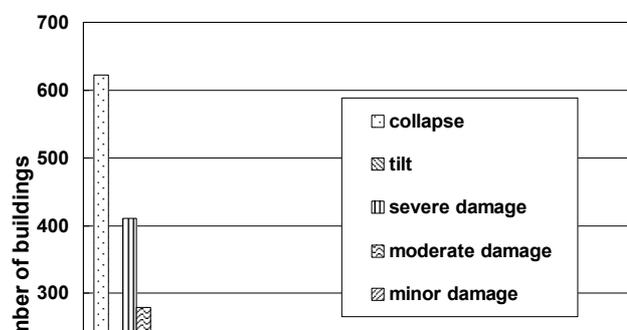
Fig. 15 Number of damaged brick structures with respect to plan configuration

also used in some rural area. Figure 15 shows that the majorities of the damaged structures are either rectangular shape or U shape floor plans. There are 1,615 damaged buildings with rectangular floor plan, which are equivalent to 84% of the total failures. And the buildings with the U shape plan configurations are another 10% of the failed structures. The remaining 6% of the damaged building are either cross shape, H shape, or other plan configurations.

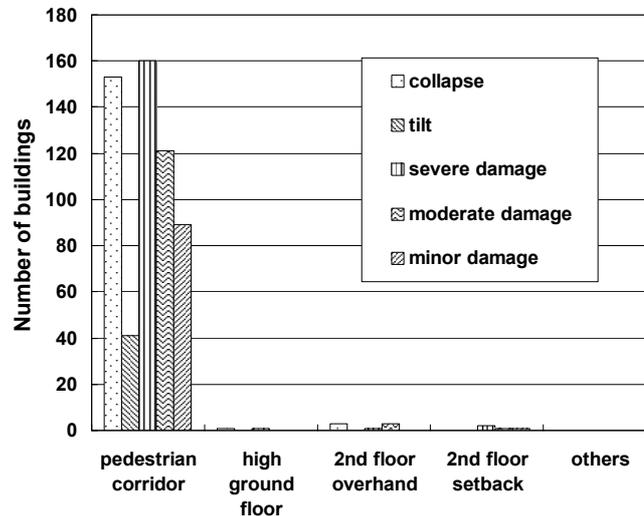
Fig. 16 Number of damaged brick structures with respect to plan configuration

It was observed from Fig. 16 that the majorities of the damages are the

buildings with pedestrian corridors. Other types of vertical configurations are the minorities.

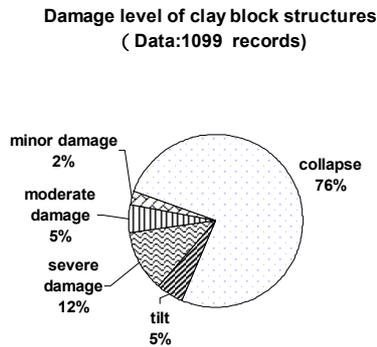
Fig. 17 Damaged percdntage of clay block structure

In the early agricultural age, prior to the introduction of the seismic design, the un-reinforced clay block is simple for the manufacture and the common usage for one story cottage construction. Lacking the seismic design concept, these buildings were constructed as a shelter for the weather protection only. Under the strong earthquake shaking, the severe damages were observed. In this report, total 1,099 un-reinforced clay block cottages were damaged, which represent the third large group of the structural failures. Figure 17 indicates that over 75% of the failed cottages are collapsed, 5% of the damaged buildings are tilted, and 12% of the failed structures are severely damaged. The poor seismic resistance of this brittle material is shown, such that over 93% of these damaged cottages are recorded as severely damaged or worse.
